# The eye of the storm

Hurricane Odile has become —along with Olivia (1967)— the most devastating ever to hit the Mexican state of Baja California Sur. Its effects also extended to other areas of the Mexican Atlantic Coast and the southwest of the United States. Odile hit land on 14 September 2014 at category 3 (Saffir-Simpson scale). There were six dead and the material damage is estimated at about 2.5 billion dollars, approximately half of which (1.2 billion) was insured. Hotel infrastructure, the area's main source of economic activity, was seriously affected. The analysis of the damage to these establishments allows us to draw conclusions on the importance of preventing this phenomenon in the hotel sector.

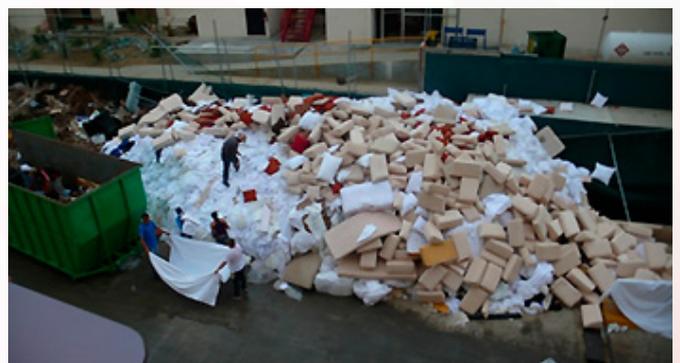
*Destroyed linens and fittings*

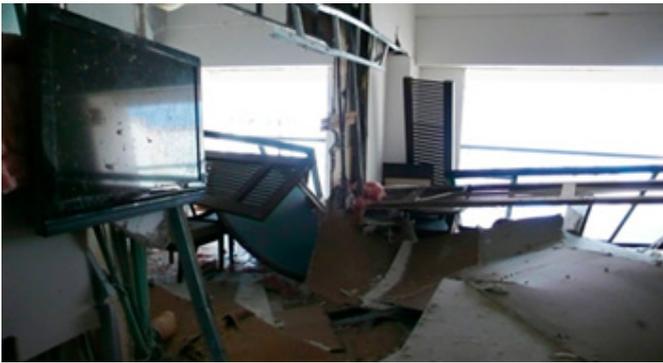
*Daños en el interior de una habitación.*

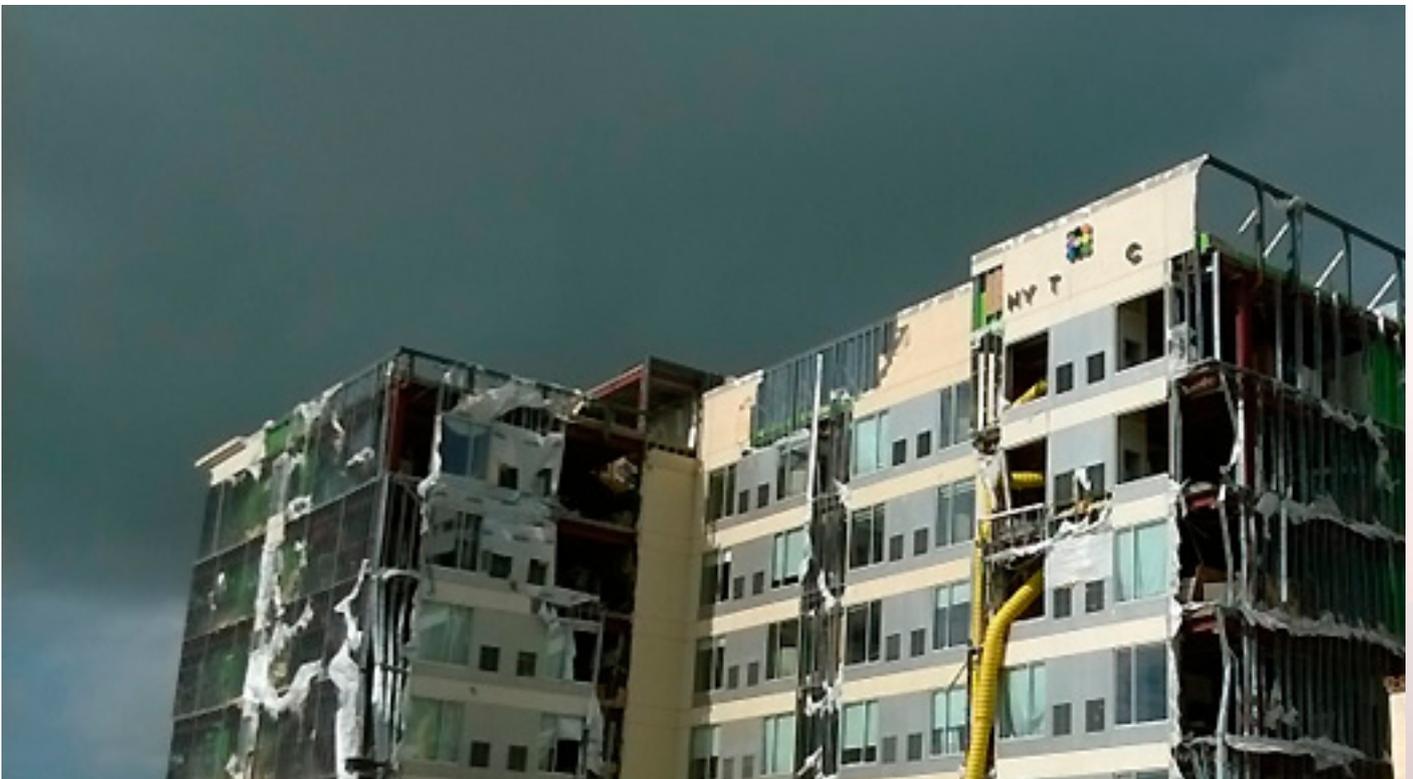
With some exceptions, tropical cyclone phenomena do not significantly damage building structures, this being understood to be the skeleton of the building; however, **walls and roofs** may be significantly affected depending on the type of material used. The passage of the hurricane revealed that solid materials (concrete, brick) show acceptable behavior, very different to the light materials, such as fibrous silicate panels, known locally as tablaroca (Sheetrock). This material is mainly used in the construction of interiors and some facades of hotel buildings in the area of Los Cabos.

*Facade built with light materials.*

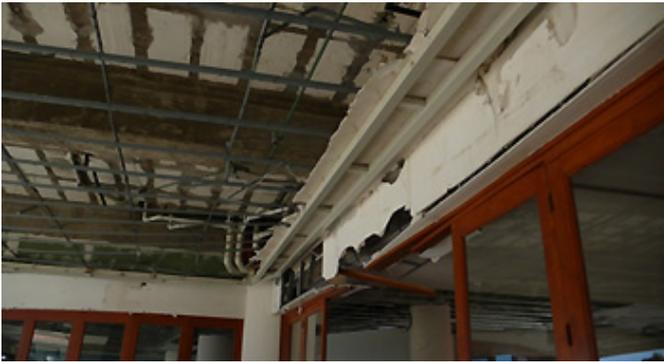
*Damaged sheet rock panelson.*

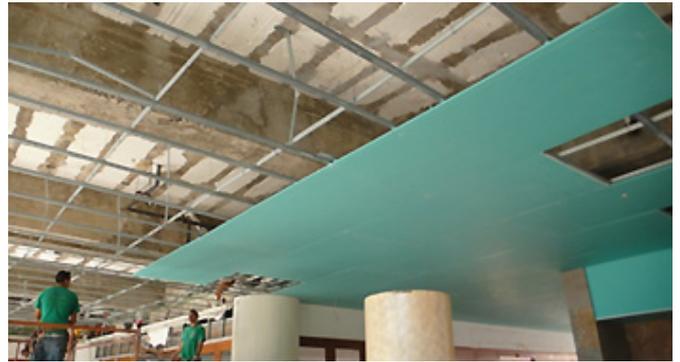
*Facade and roofs of open areas.*

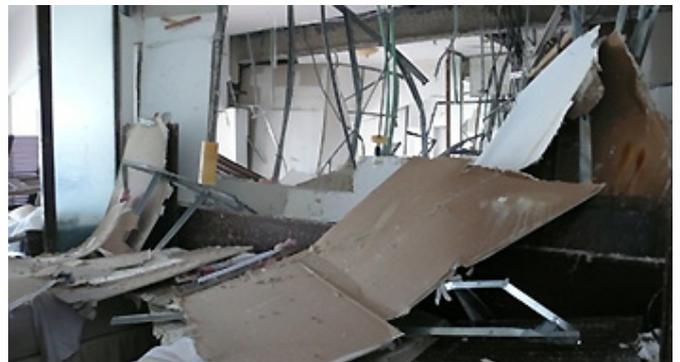
One of the most recurring problems in hotel buildings was due to **broken windows** as, even if the outer walls are sufficiently solid, once the level of resistance of the windows is exceeded, the force of the wind and water causes widespread damage in the rooms, including inner walls when they are made from light materials.

*Damaged room.*

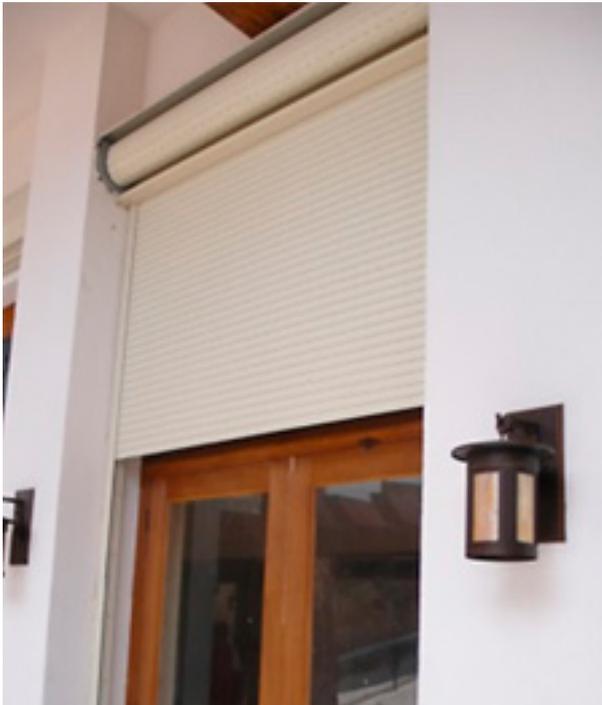
*This cyclone shutter stopped the window at the venue from being broken.*

**Cyclone shutters** are an efficient barrier for limiting interior damage, as shown in the cases analyzed and evidenced by the importance of having these types of measures. In other cases, the windows were protected with wooden boards which, although effective in many cases, did not guarantee a high level of effectiveness in the areas more directly exposed to the force of the wind.

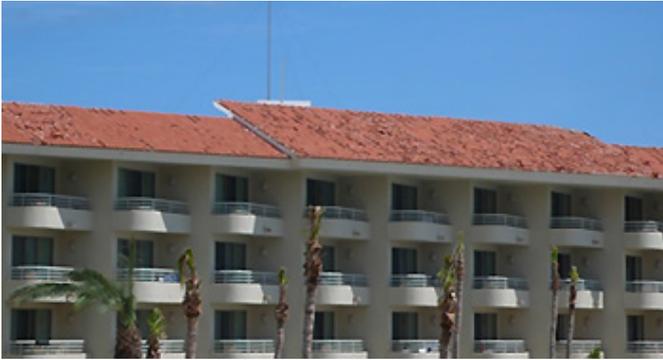
The strong gusts of wind (around 200 km/h) in many cases managed to pull the **tiles** off the roofs and turn them into projectiles that hit facades and other nearby roofs, breaking the waterproof layer and causing subsequent damage due to water ingress. The use of imitation tiles built from sheets of concrete considerably limited damages caused by this on the buildings analyzed, as their greater weight and resistance prevented them from being lifted off by the wind.

*Traditional tiles lifted by the force of the wind.*

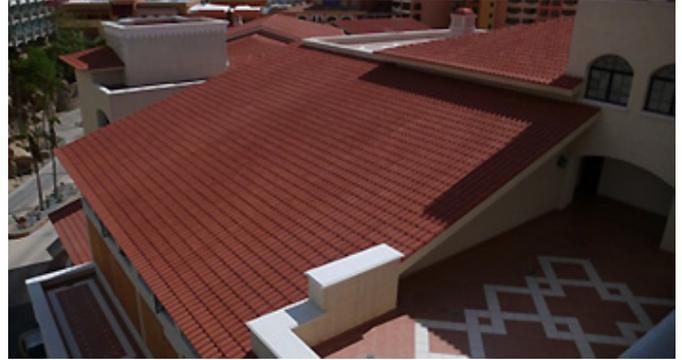
*Fake tiles (concrete) not affected.*

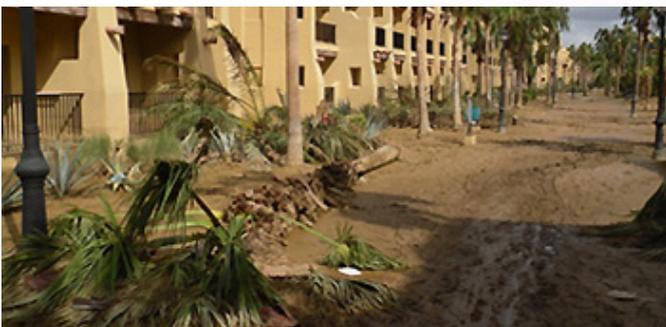
*Flooded area.*

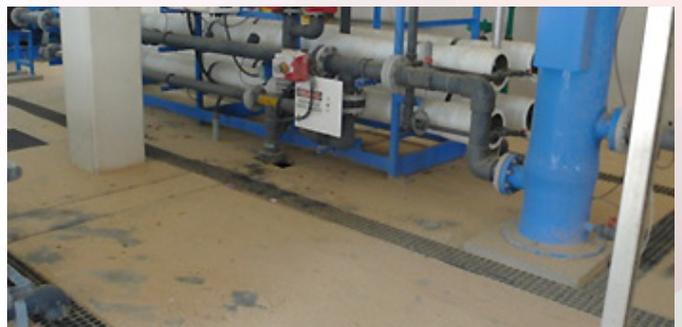
*Desalination plant at hotel affected by the ingress of salt water and sand.*
