## Analysis of the explosion of a liquefied-natural-gas road-tanker

*This article describes a liquefied-natural-gas tanker accident in the Spanish province of Murcia, with subsequent ignition and explosion of the cargo. The effects were notable in terms of thermal radiation, overpressure blast wave and flying shrapnel. This was the second known accident of this type in the world. In 2002 a similar accident occurred in Tivissa (Tarragona). This article looks at the possible causes, draws conclusions and puts forward recommendations for avoiding accidents of this type in the future.*

Authors: J.M. BONILLA MARTÍNEZ. Chemical Engineer, Industrial Engineer, Fire-fighting Officer. ([wjuanma@yahoo.com](mailto:wjuanma@yahoo.com)).

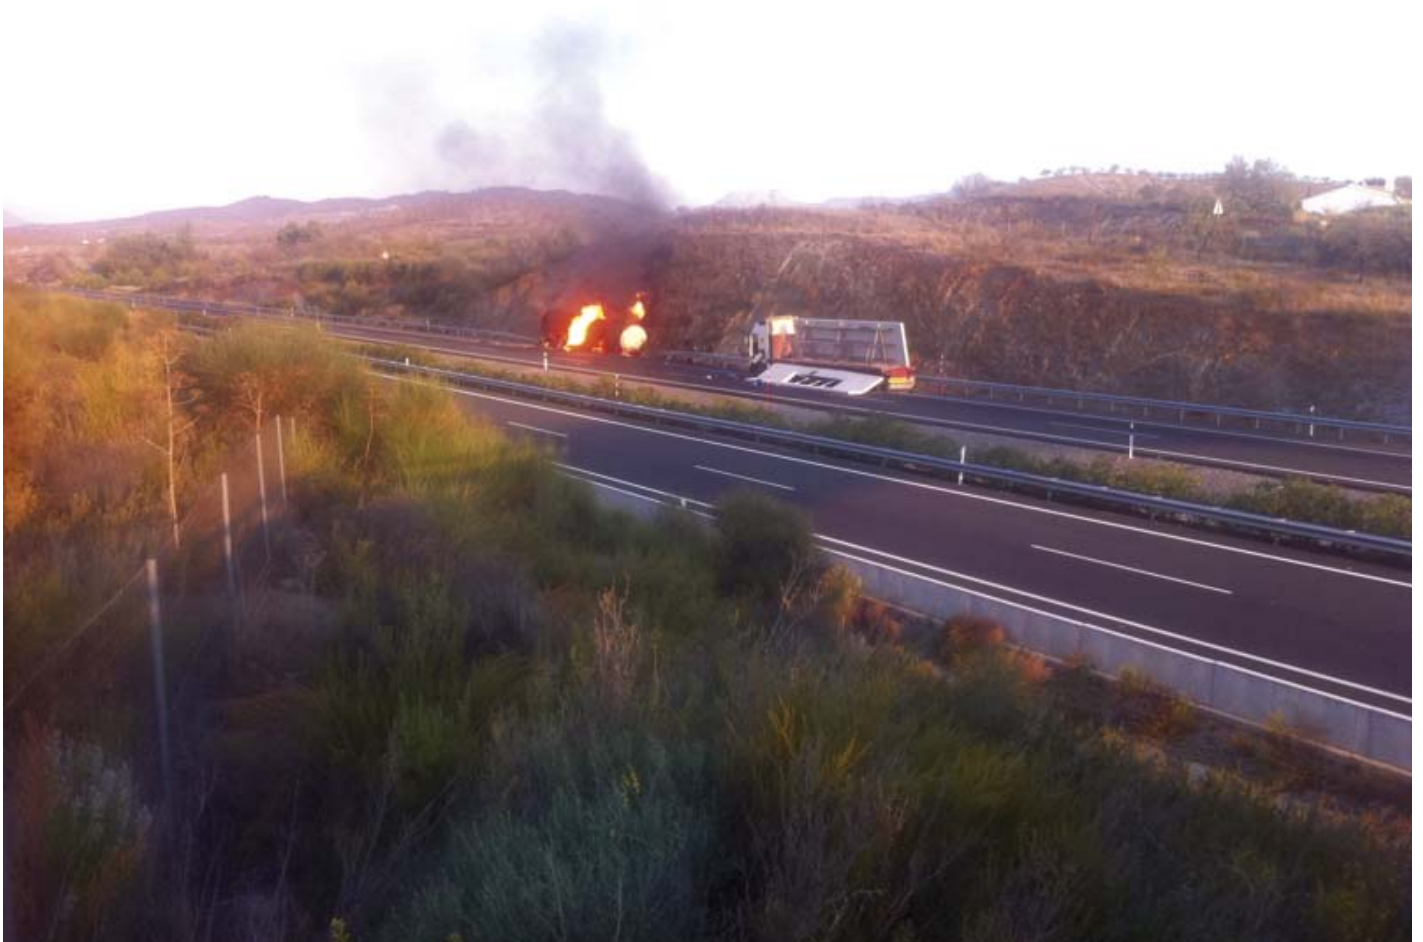
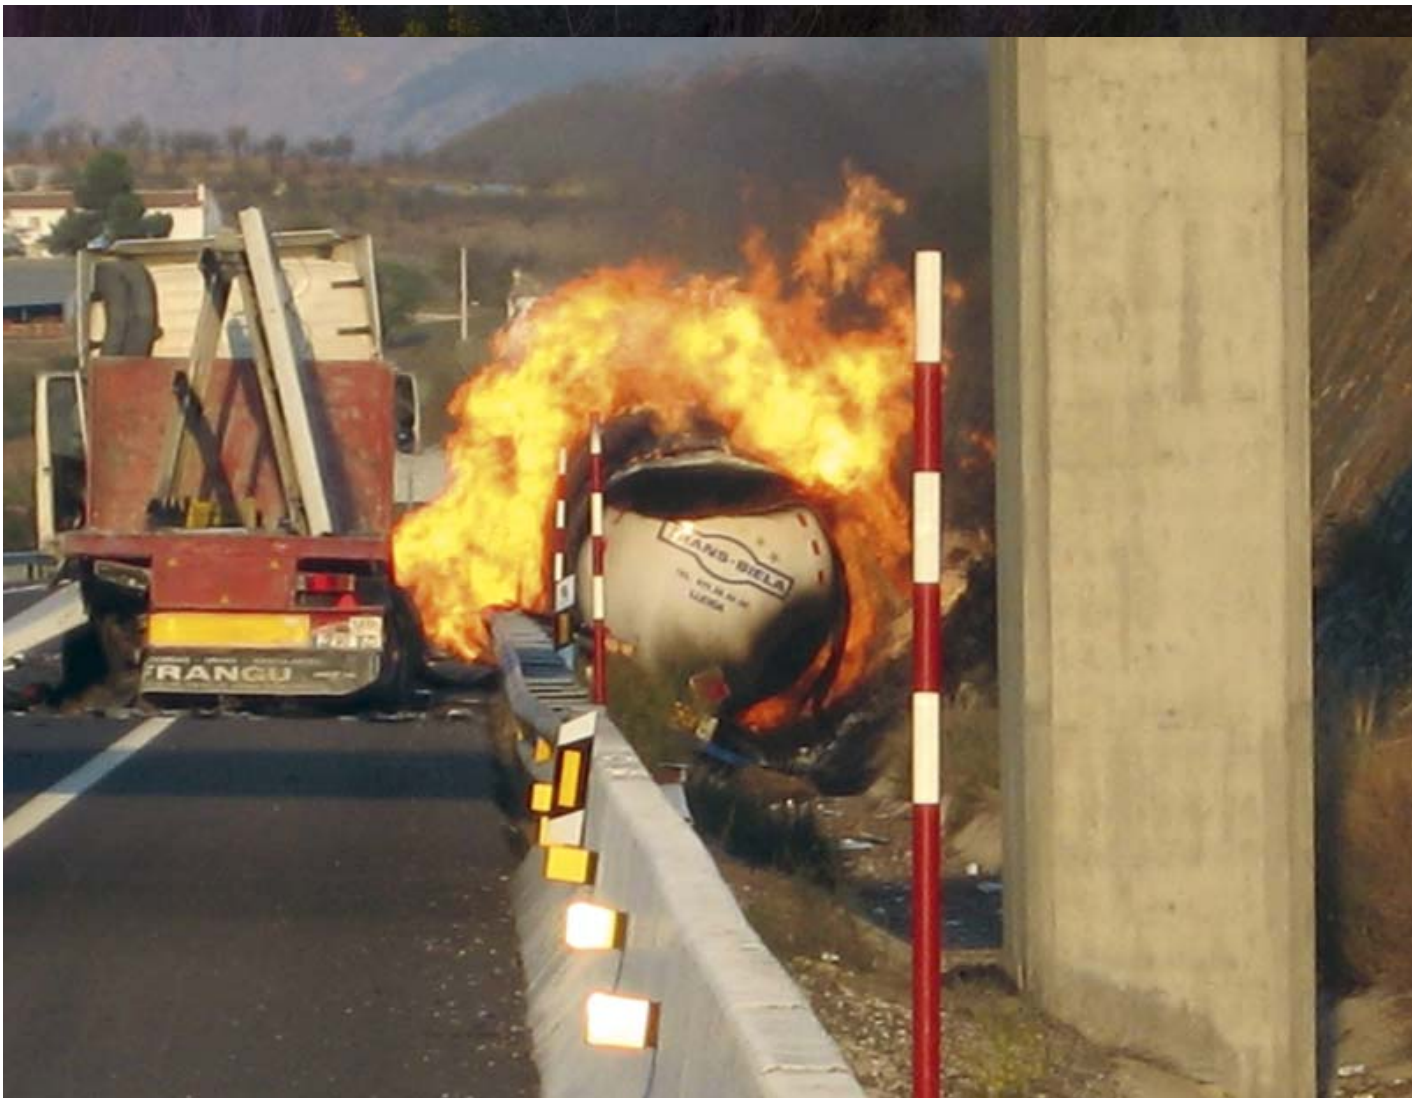
About 8:00 hours that morning a lorry carrying large prefabricated concrete sheets stopped on the motorway hard shoulder due to a breakdown. About twenty minutes later the road tanker ran into the back of the parked lorry. As a result of the crash the driver lost control of the road tanker, which ran on past the flat-bed lorry, broke through the hard-shoulder crash barrier and became wedged in a ditch against the embankment. The lorry ended up on its wheels, leaning over to the right due to the slope of the ditch; the cab was jack-knifed back towards the trailer, remaining trapped between trailer and embankment.

Figura 2. Situation of the vehicles after the accident. Source<sup>(2)</sup>.

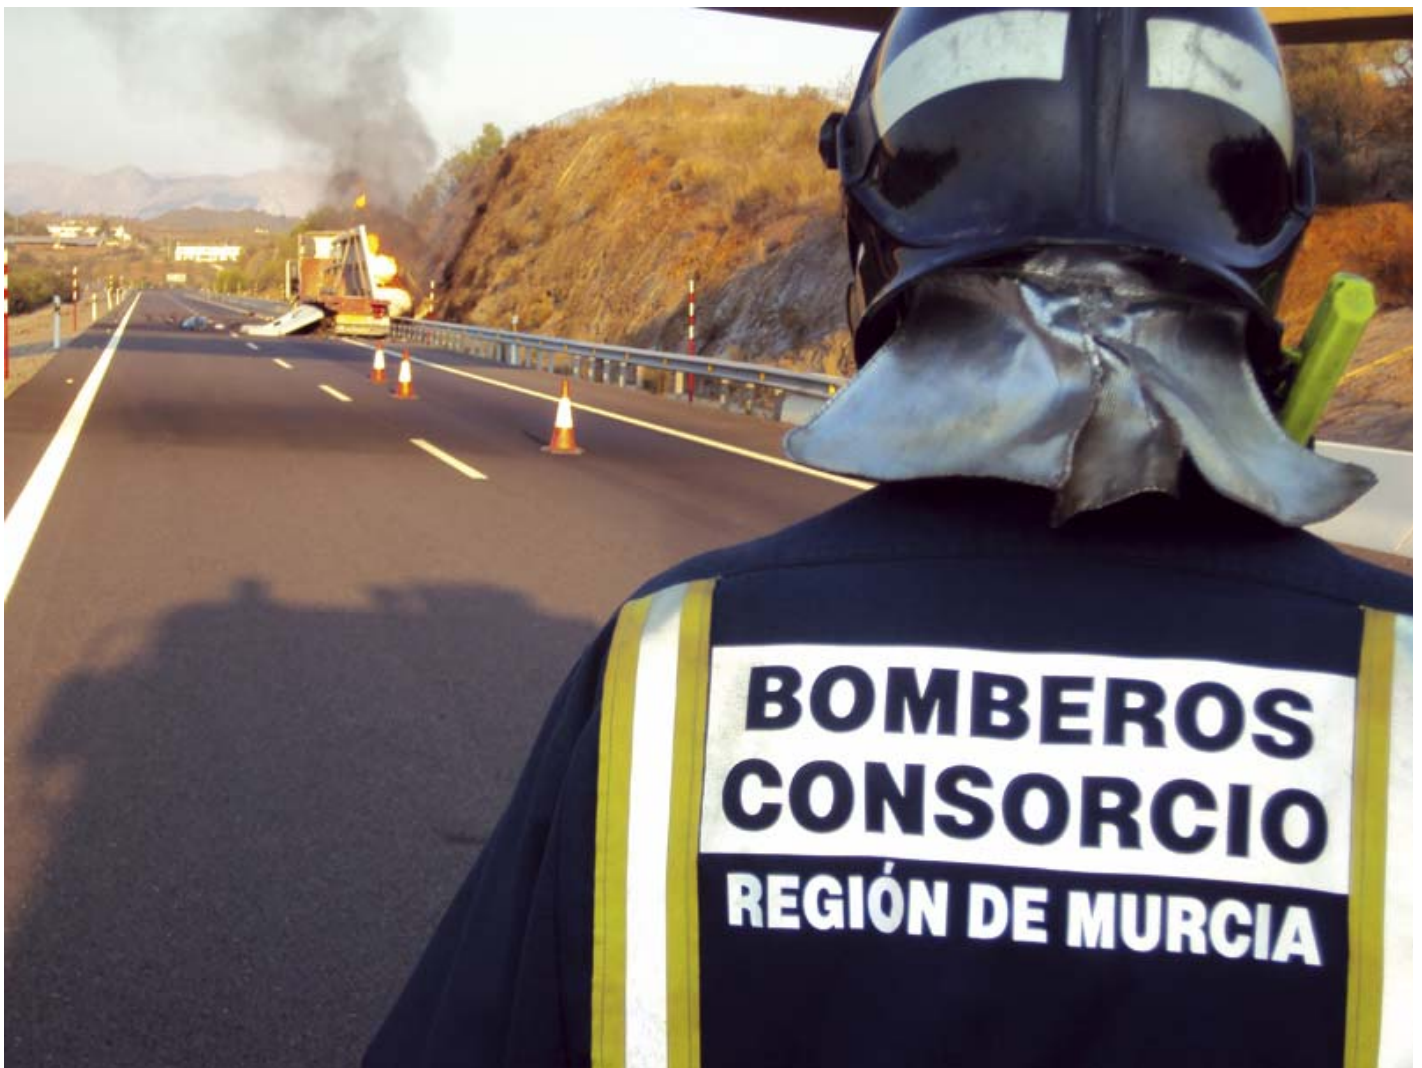
An on-the-spot witness called the 112 emergency service, thereby activating the accident-response mechanisms. The time by now was 8:21 and the first fire-fighting crew was mobilised from Lorca fire station, belonging to the *Consortio de Bomberos de la Región de Murcia* (Consortium of Firefighters of the Region of Murcia), at about 31 km from the crash site. The initial information they received upon leaving the depot was that of a lorry fire with the driver trapped inside. On the journey they were told that the crash might involve a natural gas tanker. The first action on arrival was to cross-check the information received during the journey. Involvement of a liquefied natural gas tanker was soon confirmed, and also that the driver was trapped inside the cab, which by then was enveloped in flames. They also observed the almost complete loss of the road tanker shell and part of the insulation. Smoke emission had diminished considerably, suggesting that the fire was now feeding solely on the tanker contents.

Figure 3. View of the road tanker upon arrival of the fire-fighting force. Source: On-the-spot witness.

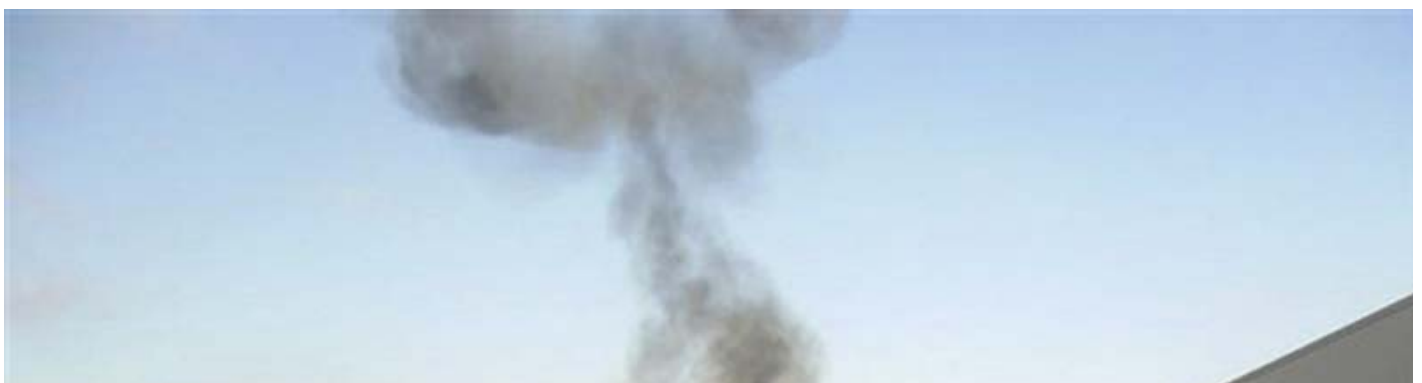
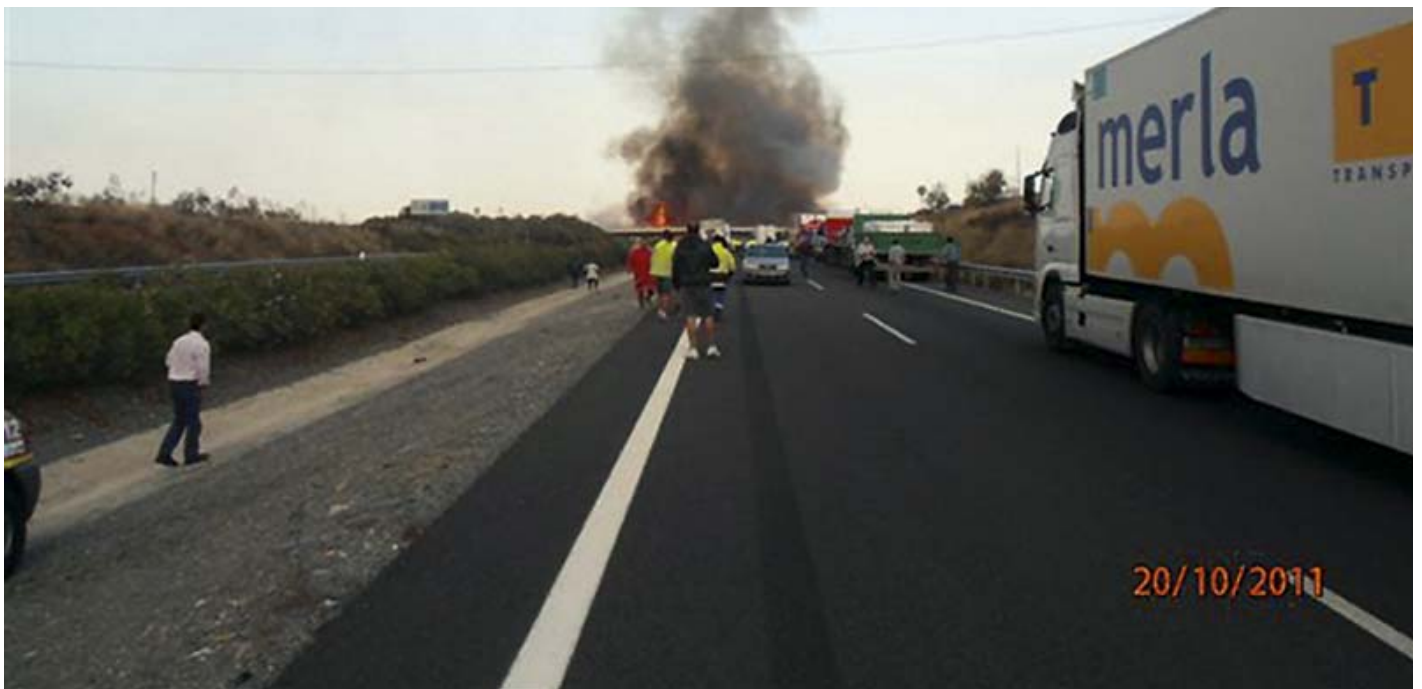
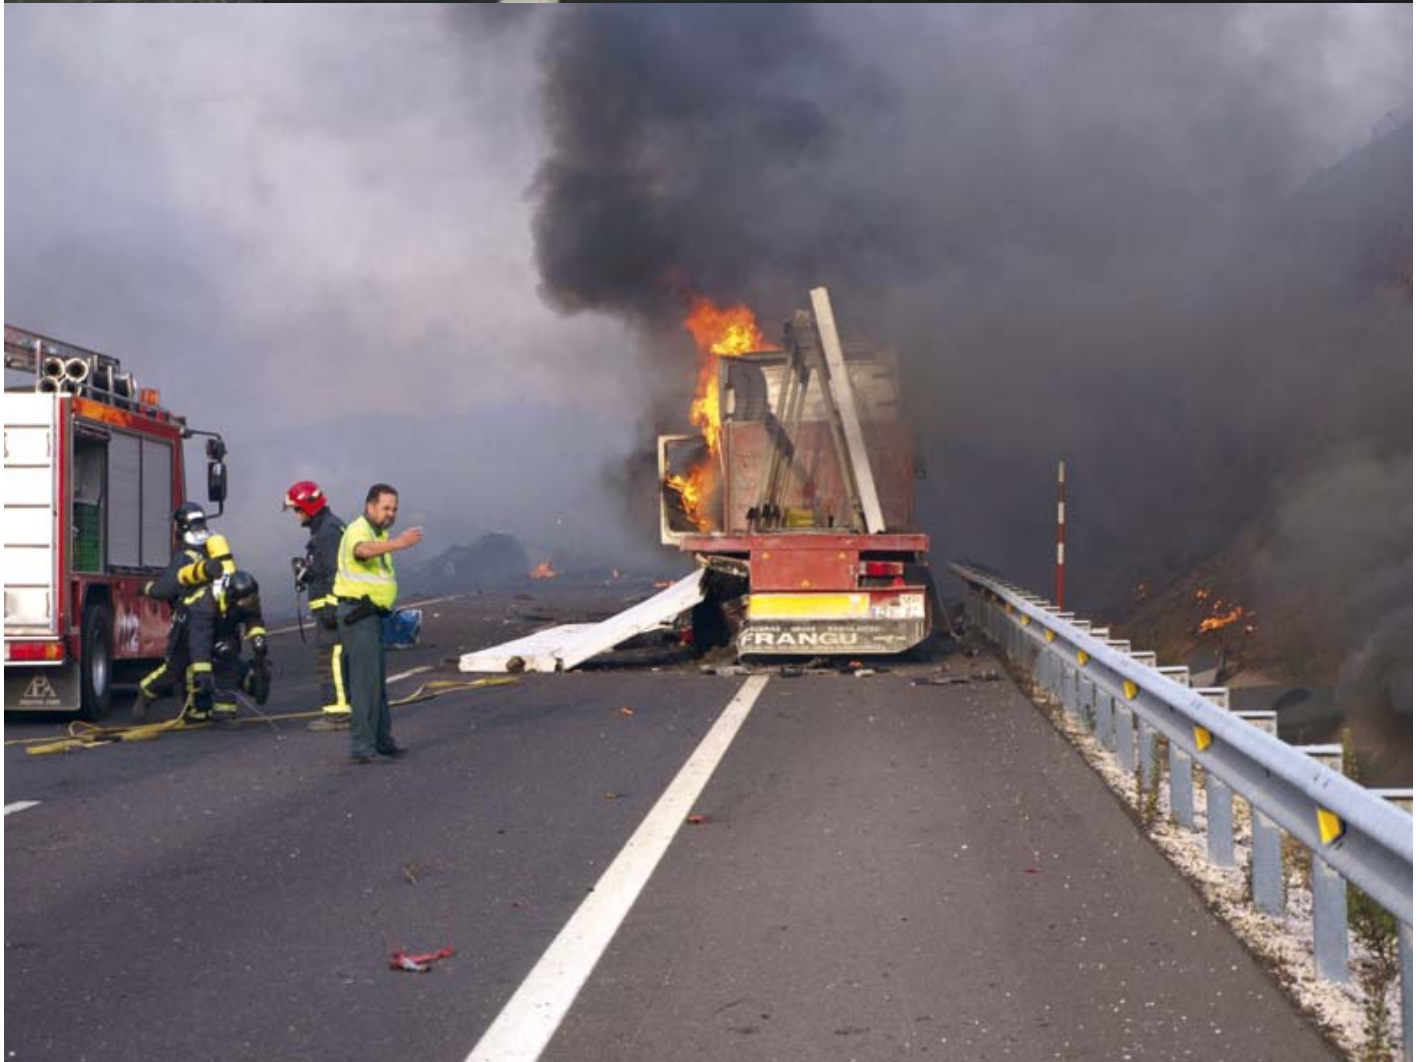
After the explosion the tanker broke up into several chunks and scattered fires broke out in a small orchard on top of the embankment and in various zones of scrubland around the tanker. The fires were extinguished without further mishap. At 10:05 hours the driver's body was recovered from the vehicle and the emergency was declared to be at an end at 10:52 hours.

Figure 4. Moments after the explosion. Fire outbreaks. Source: On-the-spot witness.

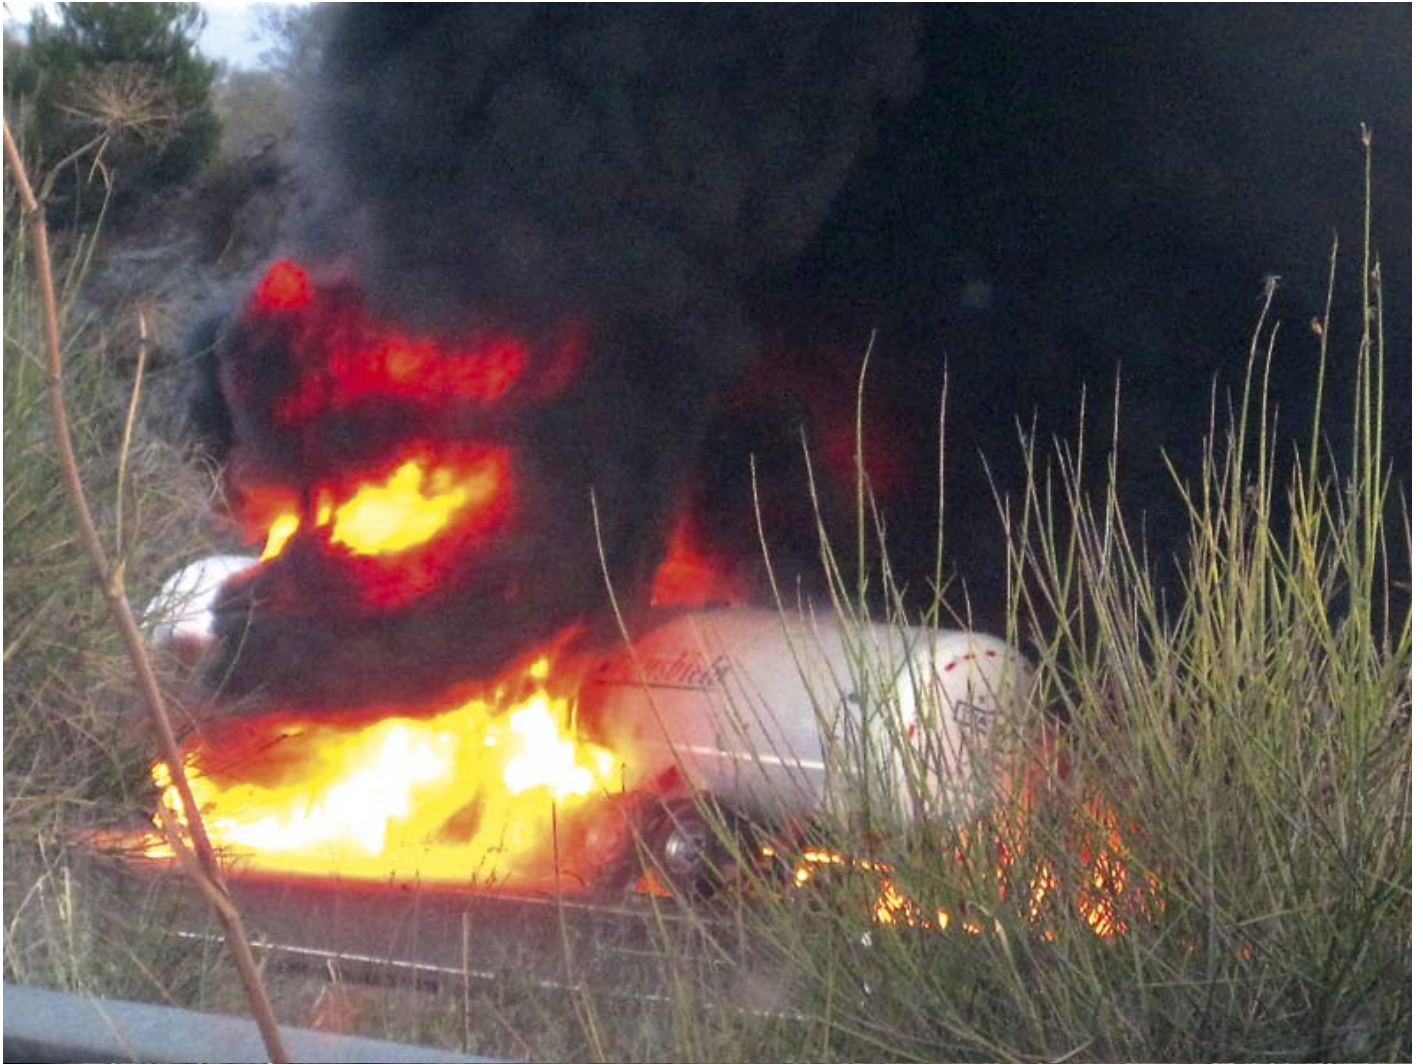
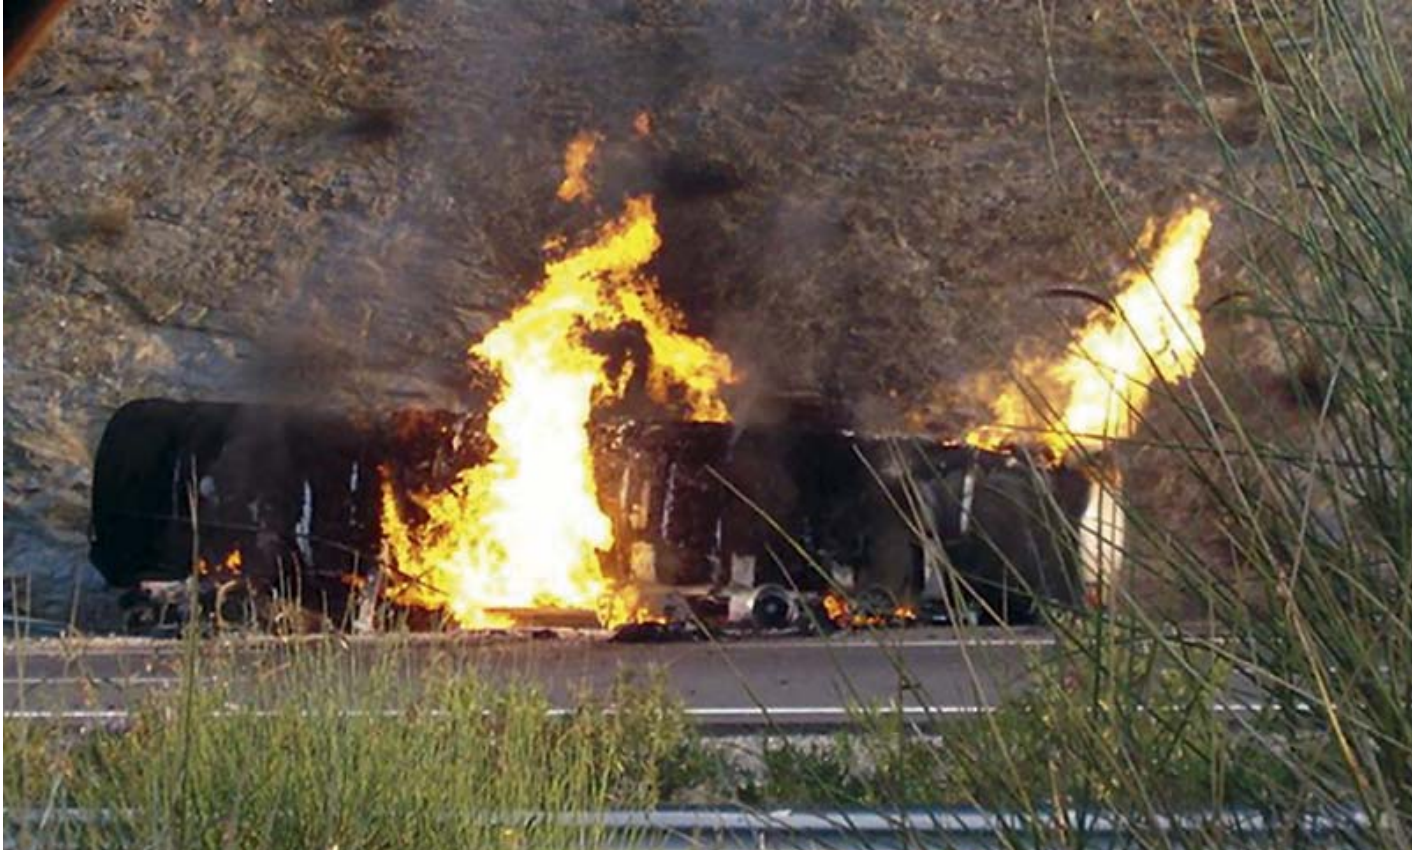
The fire was fierce right from the start since all combustible elements of the cab, wheels and vehicle fuel quickly caught fire, totally enveloping the centre of the tanker. After these items had been burnt off, the density of the smoke felt appreciably and the total destruction of the shell came to light, except for the back end; the fire was by now reduced to two huge plumes, one in the central part and another in the righthand rear of the tanker, as shown in the following photographs. Nonetheless, it could in fact be a case of a single fire source broken up into two by a rebound effect from the underneath part on the road and embankment.

Figure 5. Fire in the initial moments and before the explosion. Source: On-the-spot witness.

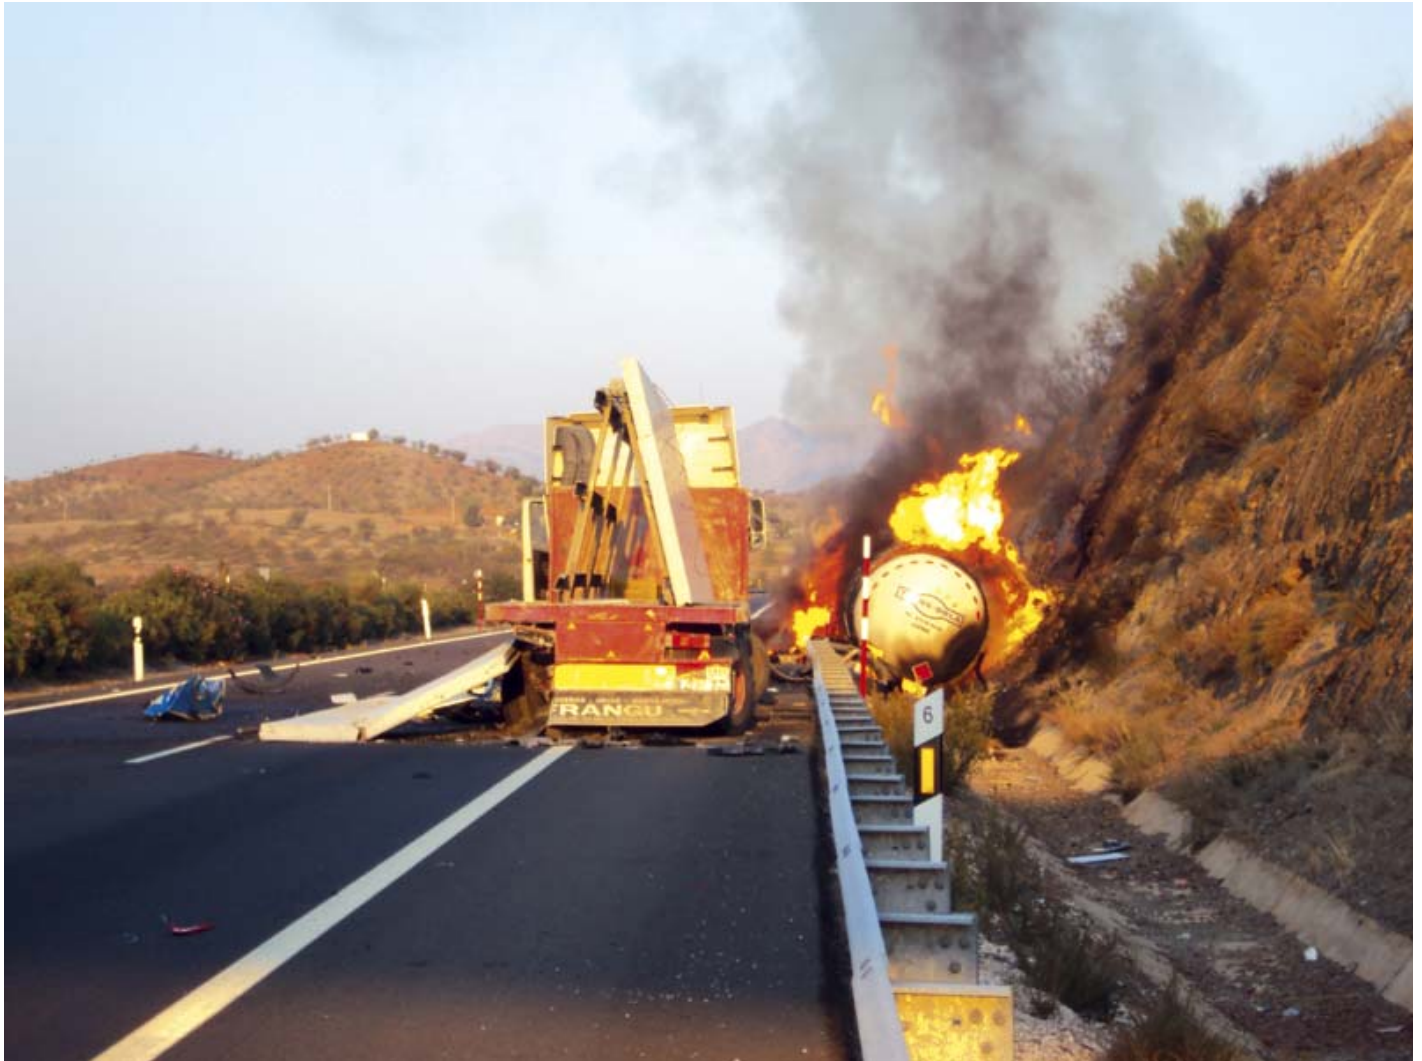
that the crash caused a leak in the tanker's load; subsequent friction or the vehicle's engine or a similar cause would then act as ignition source. This chimes in with the reports of several eye witnesses, declaring that they heard "a sort of loud hiss", as well as the diverse tanker fragments found around the flat-bed lorry and the ignited plumes. Several possibilities have been put forward as the cause of the leak. As well as the cab the central part of the tanker also crashed into the parked flat-bed lorry. This central part houses the loading and unloading devices, safety valves and level gauges. A large part of the blue cabinet containing the abovementioned devices was found very close to the flat-bed lorry. This would seem to show that the valve-containing part suffered a collision, with resulting damage to some of the pipelines.

Figure 6. Remains of the tanker's lower central cabinet (blue fragments to the left). Source: On-the-spot witness.

What seems to be totally ruled out, even though this working hypothesis was considered at first, is perforation of the tanker from the crash against the back corner of the flat bed. If so there would be remains of the shell and insulation on the back part of the broken-down lorry and no such evidence has come to light. Moreover, all the photos studied show clearly that the leak was located in the lower central part. In any case these hypotheses are not mutually exclusive; the combined effect of several of these causes might have broken some of the pipelines not fitted with inner gas-tight valves, producing a leak of the cargo.

4. Last but by no means least, urge the competent authorities to dictate that liquefied natural gas should always be transported in double-walled road tankers, for greater safety, or, in the case of single-walled tankers, ensure that there are no pipelines directly communicating the liquid and gaseous phases with the exterior, lacking any additional cut-off device in the event of accidental sectioning.

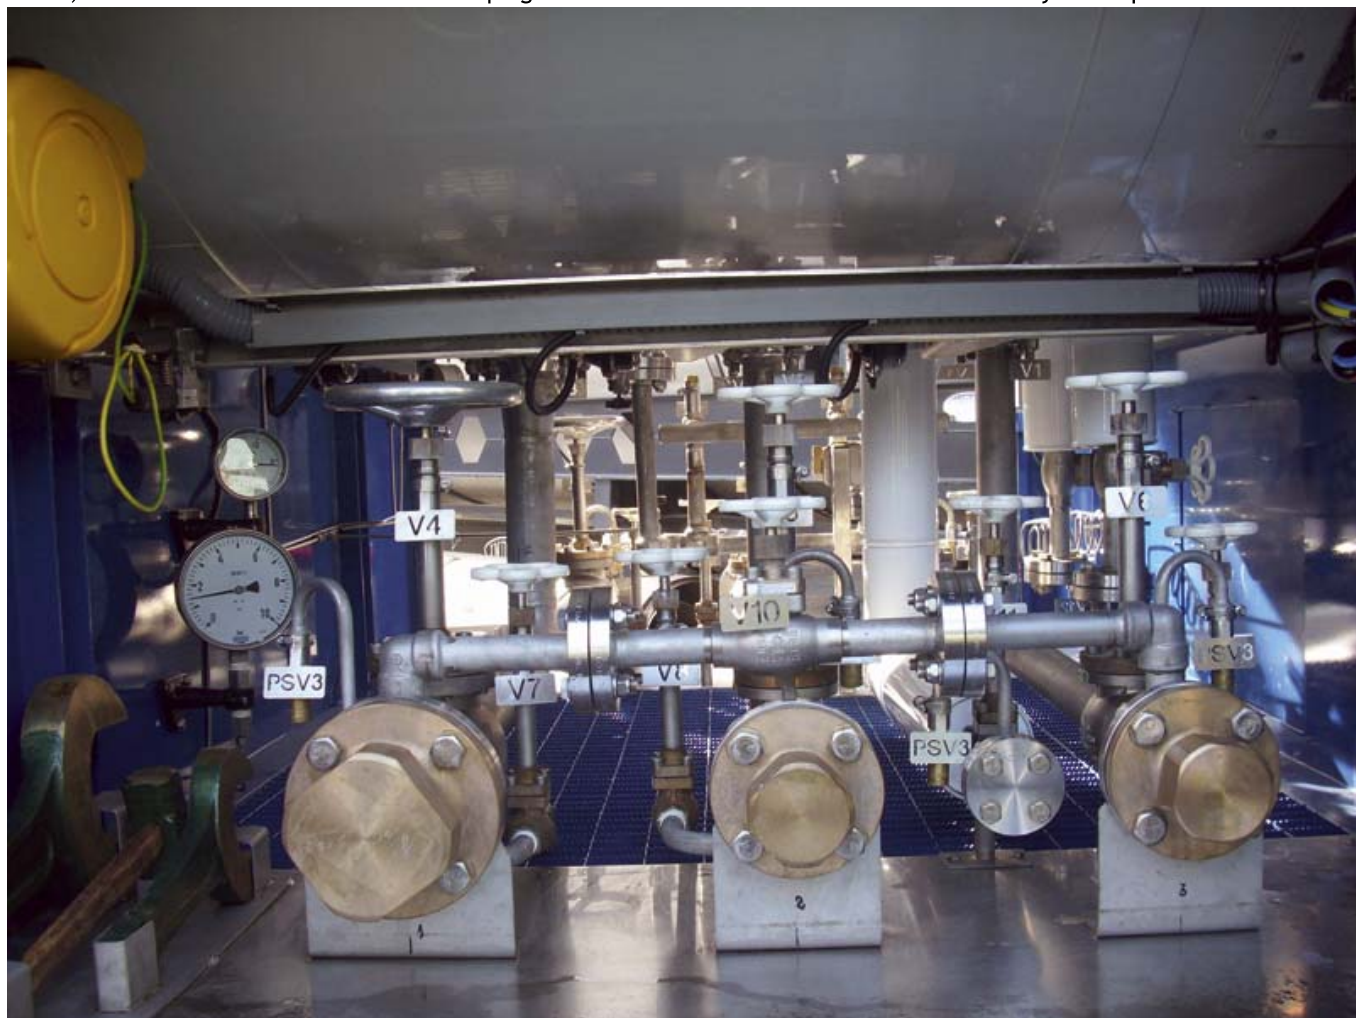
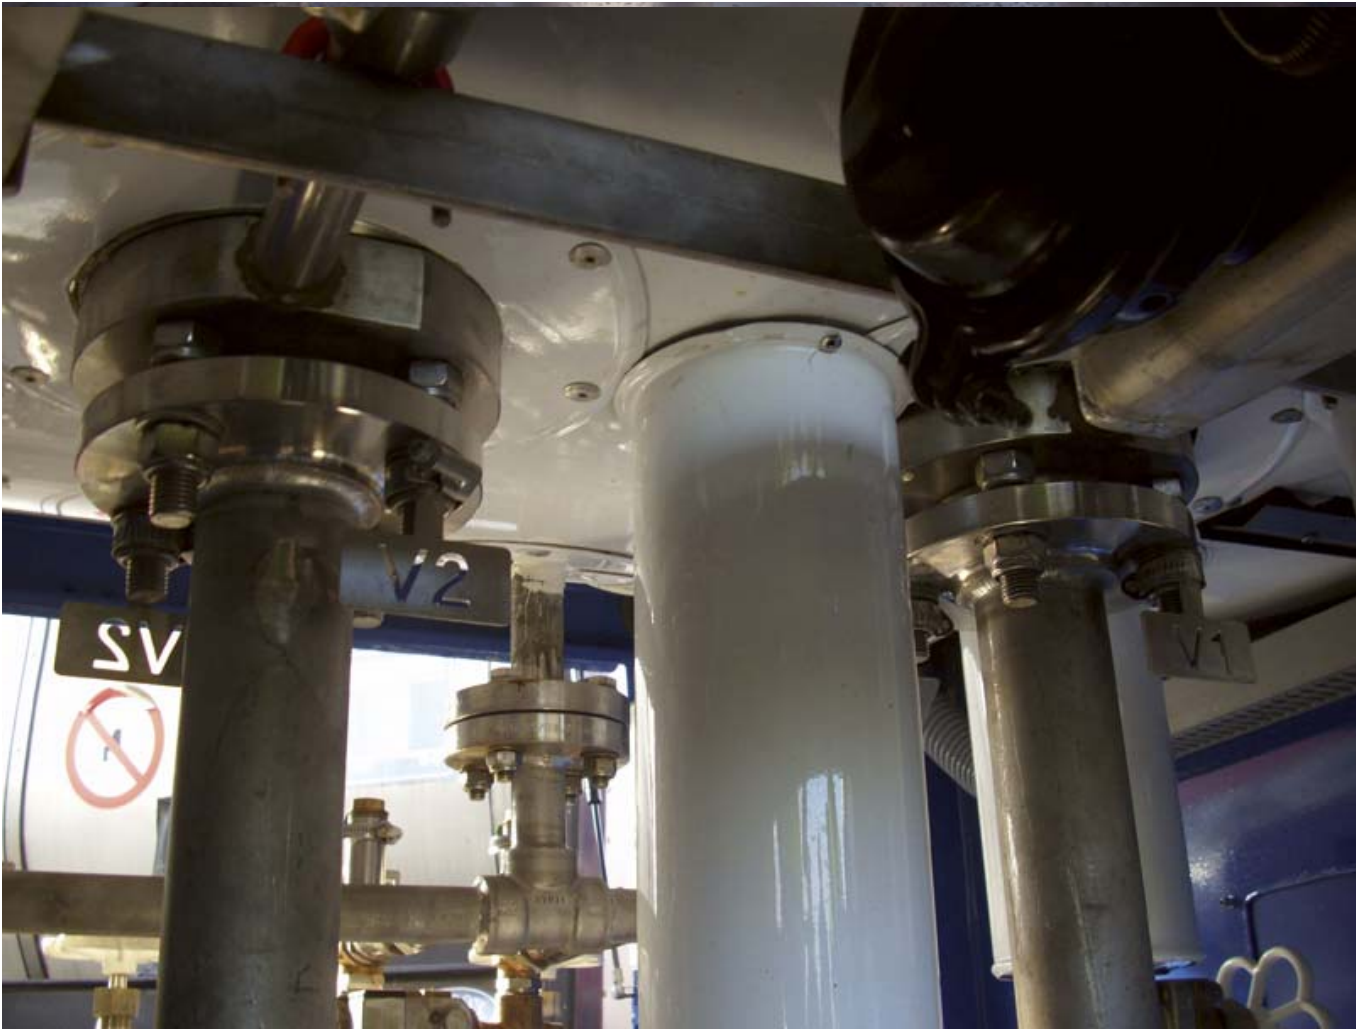
Figure 7. General view of the set of valves and pipelines. In the foreground, the loading and unloading connections. The right-hand photo shows a detail of the inner plug valves. Source<sup>(4)</sup>: Authors.

Of all the abovementioned devices and pipelines only the loading and unloading connections are fitted with inner seal valves guaranteeing tank gas-tightness; in the event of any breakage in pipes connected up to these valves, any leaks would be blocked off from inside. Although it seems obvious that the tanker's cabinet area struck the parked flat-bed lorry, as shown by the remains of this cabinet on the road surface, the available photos do not allow us to ascertain the state of these valves since this part of the inside of the tanker is not shown. Nonetheless, this hypothesis seems less probable than breakage of another pipeline not fitted with plug valves.

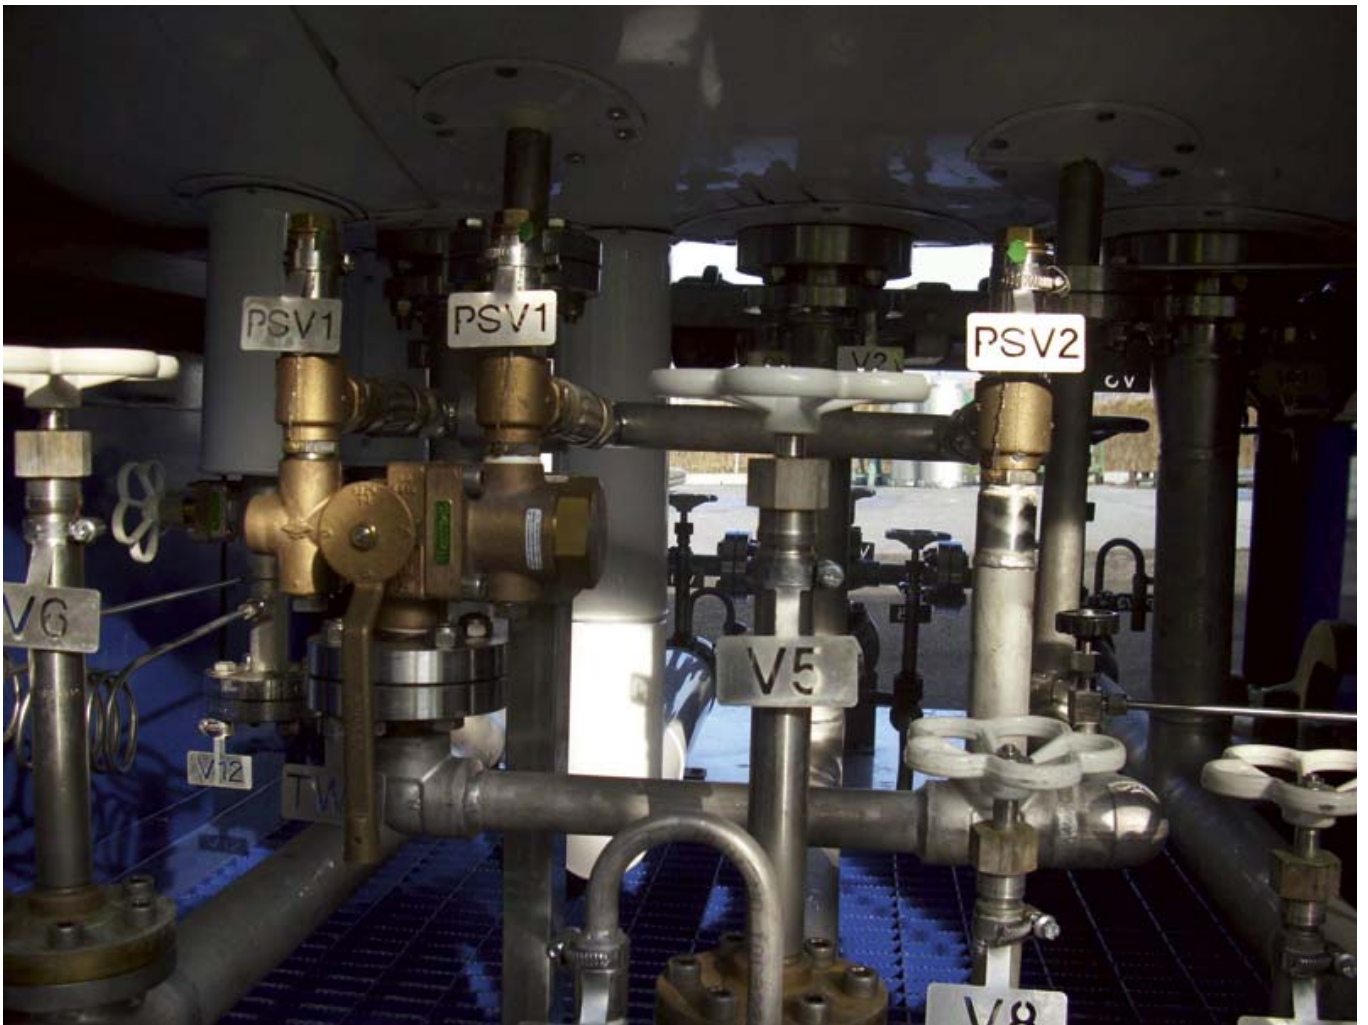
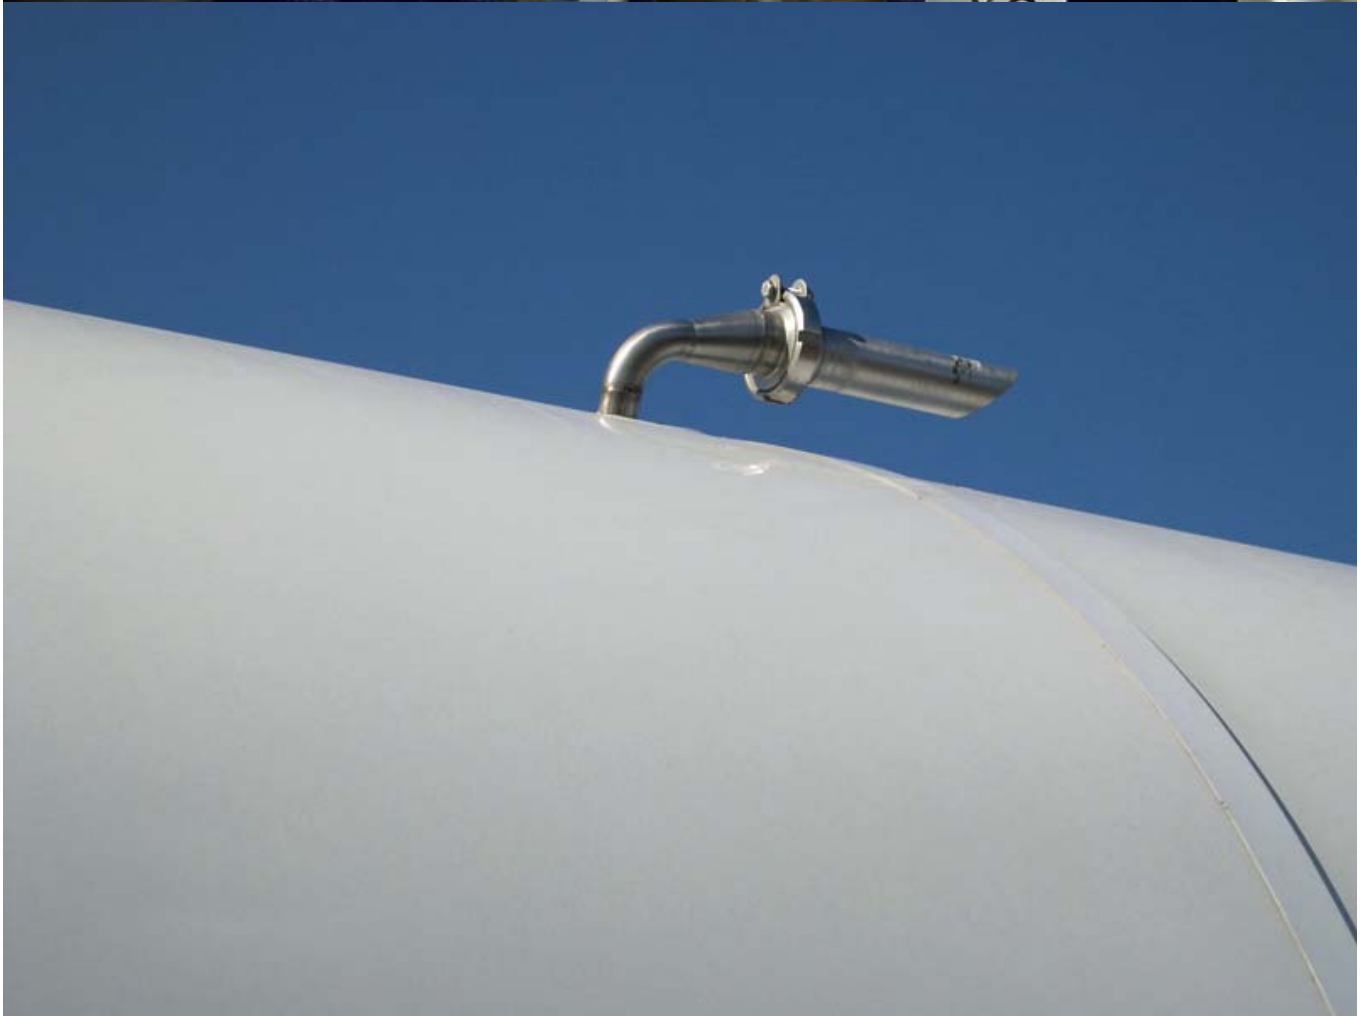
- **Safety valves.** It is fitted with three safety valves, two rated at 7 bar and one at 9 bar. They link up with the gaseous phase by means of an immersion tube running the whole length of the tanker under the lower insulation and coming up through the front end to connect up with the storage tank. The outlet of the safety valves communicates with another tube that rises up flush with the tanker at the centre (always beneath the insulation) and then runs back along the top to the rear, where it relieves excess pressure through a venting device.

Figure 8. Safety valves and venting device. Source(4): Authors.

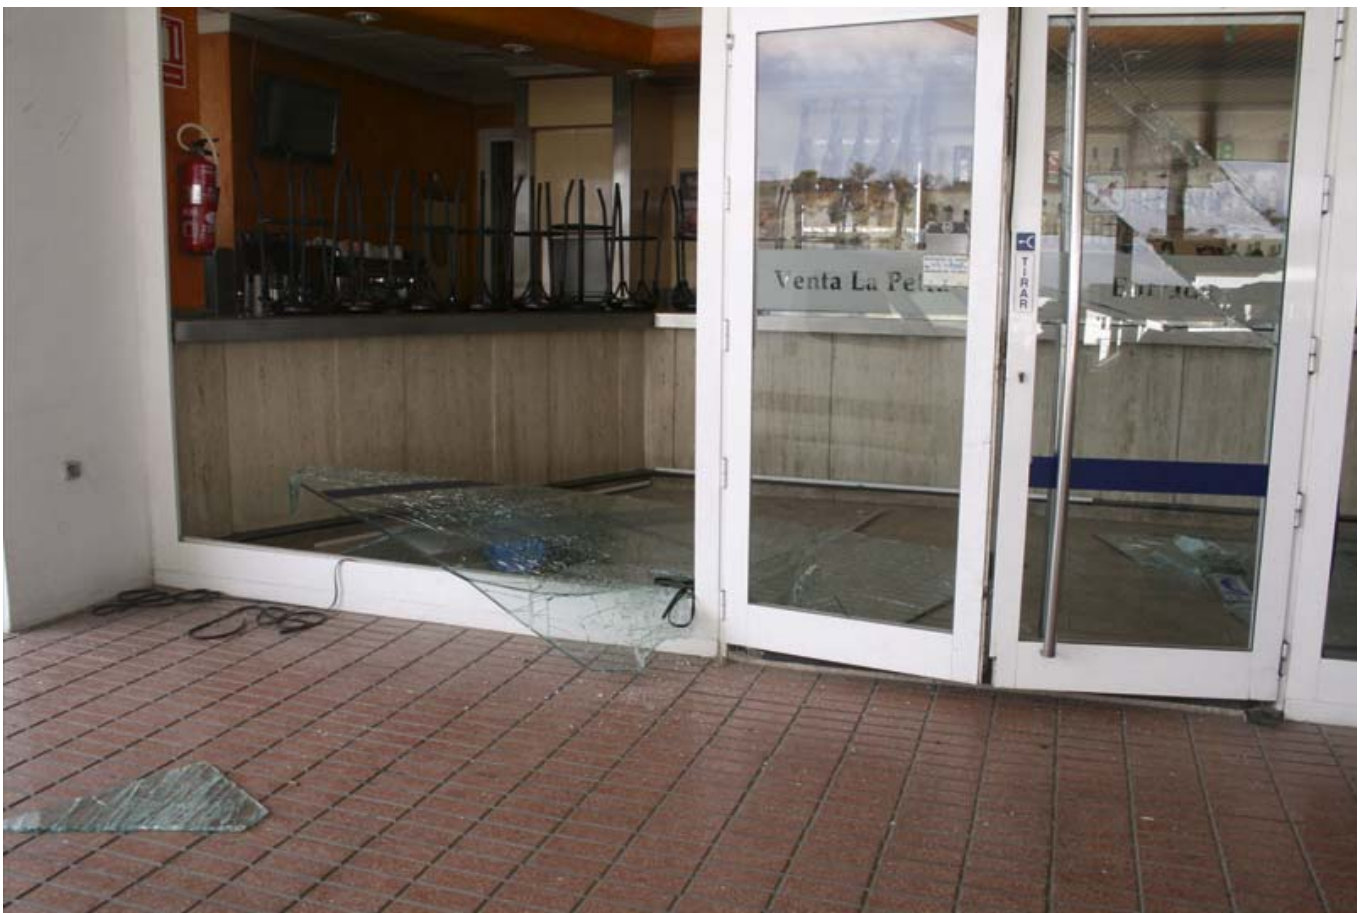
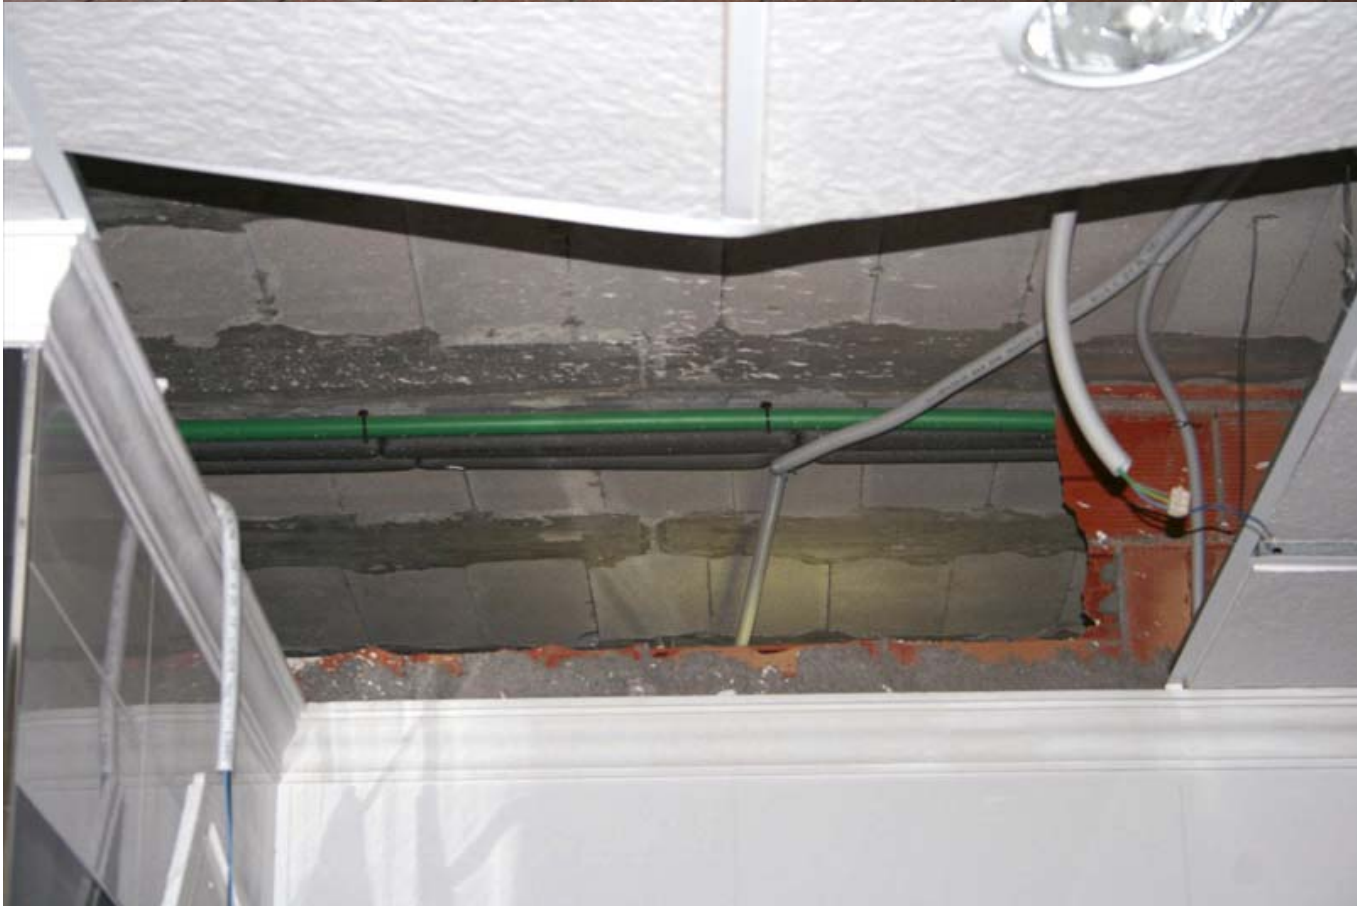
The petrol station's inner roof slats were warped and torn off on the western side, taking the A-91 in the direction of the accident as east-west reference. Cracks also appeared in the wall of the petrol station building.

The petrol station windows, seals included sometimes, were blown inwards. There was widespread breakage of glass. In the motorway services area the false ceiling is made of plasterboard panels mounted on aluminium rails. Some of them were raised by the shock wave. Cracks, without any structural ramifications, also appeared in the column covering. Judging from the 80% glass breakage the overpressure blast wave is estimated to have had a maximum value ranging from 0.03 to 0.04 bar.

Lastly, a lamppost with a column height of about 15 metres, standing near the petrol station at a distance of 170m from the explosion, was bent 25° out of true.

Figure 9. Petrol station damage caused by overpressure blast wave. Source<sup>(4)</sup>: Authors.
