## Analysis of the explosion of a liquefied-natural-gas road-tanker

*This article describes a liquefied-natural-gas tanker accident in the Spanish province of Murcia, with subsequent ignition and explosion of the cargo. The effects were notable in terms of thermal radiation, overpressure blast wave and flying shrapnel. This was the second known accident of this type in the world. In 2002 a similar accident occurred in Tivissa (Tarragona). This article looks at the possible causes, draws conclusions and puts forward recommendations for avoiding accidents of this type in the future.*

Authors: J.M. BONILLA MARTÍNEZ. Chemical Engineer, Industrial Engineer, Fire-fighting Officer. ([wjuanma@yahoo.com](mailto:wjuanma@yahoo.com)).

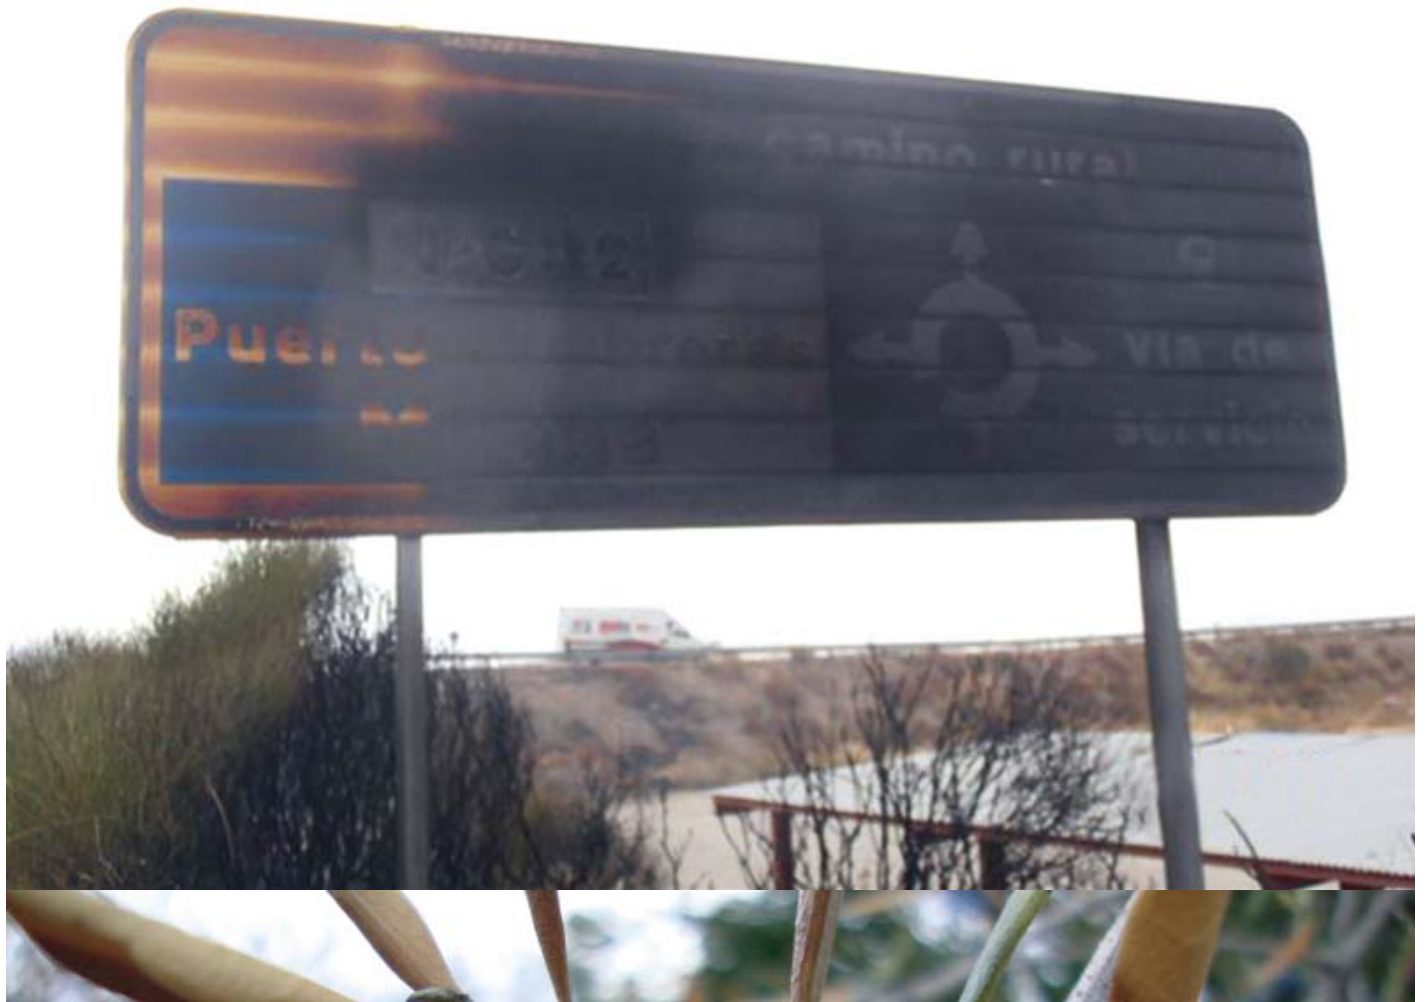
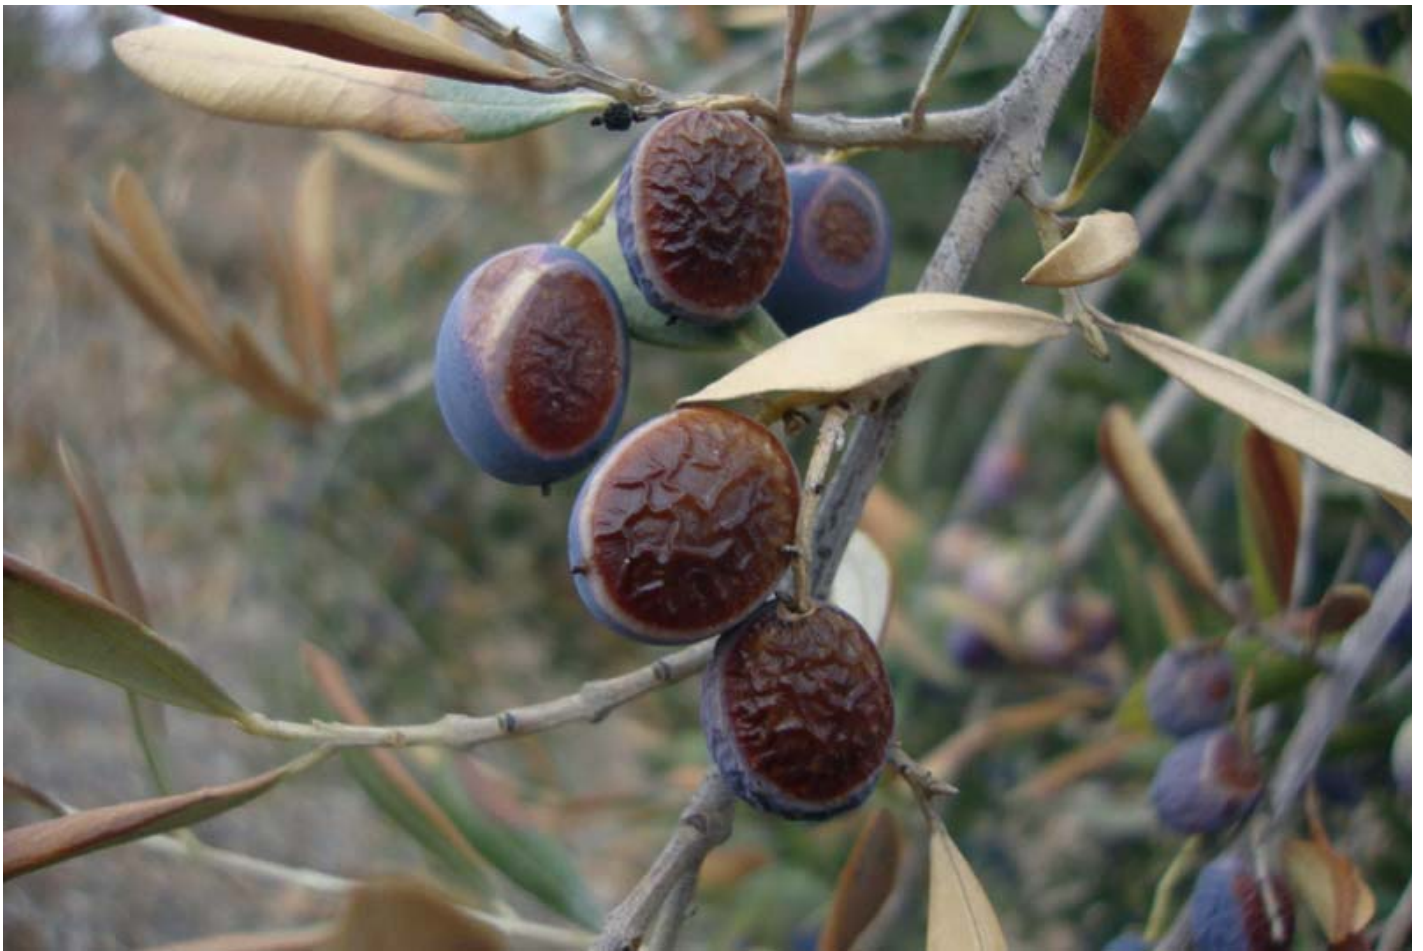
According to J.E.E., fire broke out all around after the explosion. This is confirmed by the burn marks in the terrain revealing the spread of small scrub fires, especially on the hard shoulders of the service road and the central reservation of the motorway. Olive trees and their fruit, growing at 110 metres from the explosion point were affected, as shown in the following photograph.

Figure 10. Radiation damage to a road sign and olive tree. Source<sup>(4)</sup>: Authors.

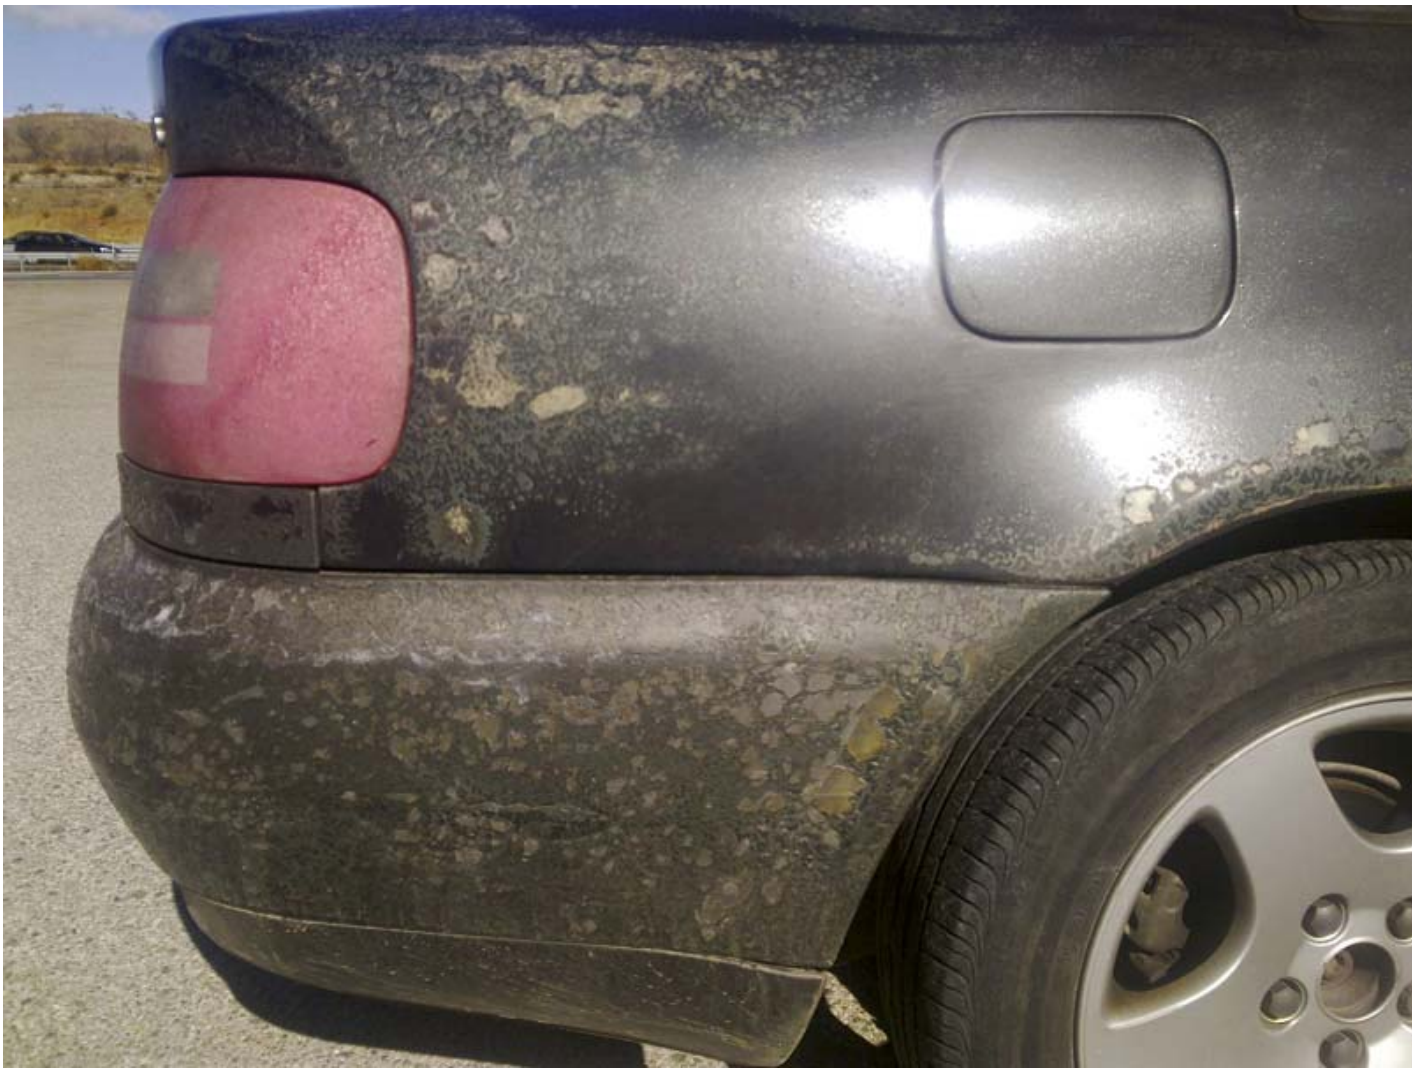
In the Zarzalico accident, although the petrol station, its surroundings and the motorway-cutting in both directions were all evacuated, two people were only a few metres from the site at the moment of the explosion. One of them was driving a car along a country path towards the service road and the other was sleeping overnight in a refrigerated lorry at the petrol station. Neither of them came to any harm since the vehicle cabs in both cases maintained life-compatible conditions. Without any doubt the fact that their windows were closed saved their lives.

Figure 11. Radiation marks on a nearby vehicle. Source<sup>(4)</sup>; Authors

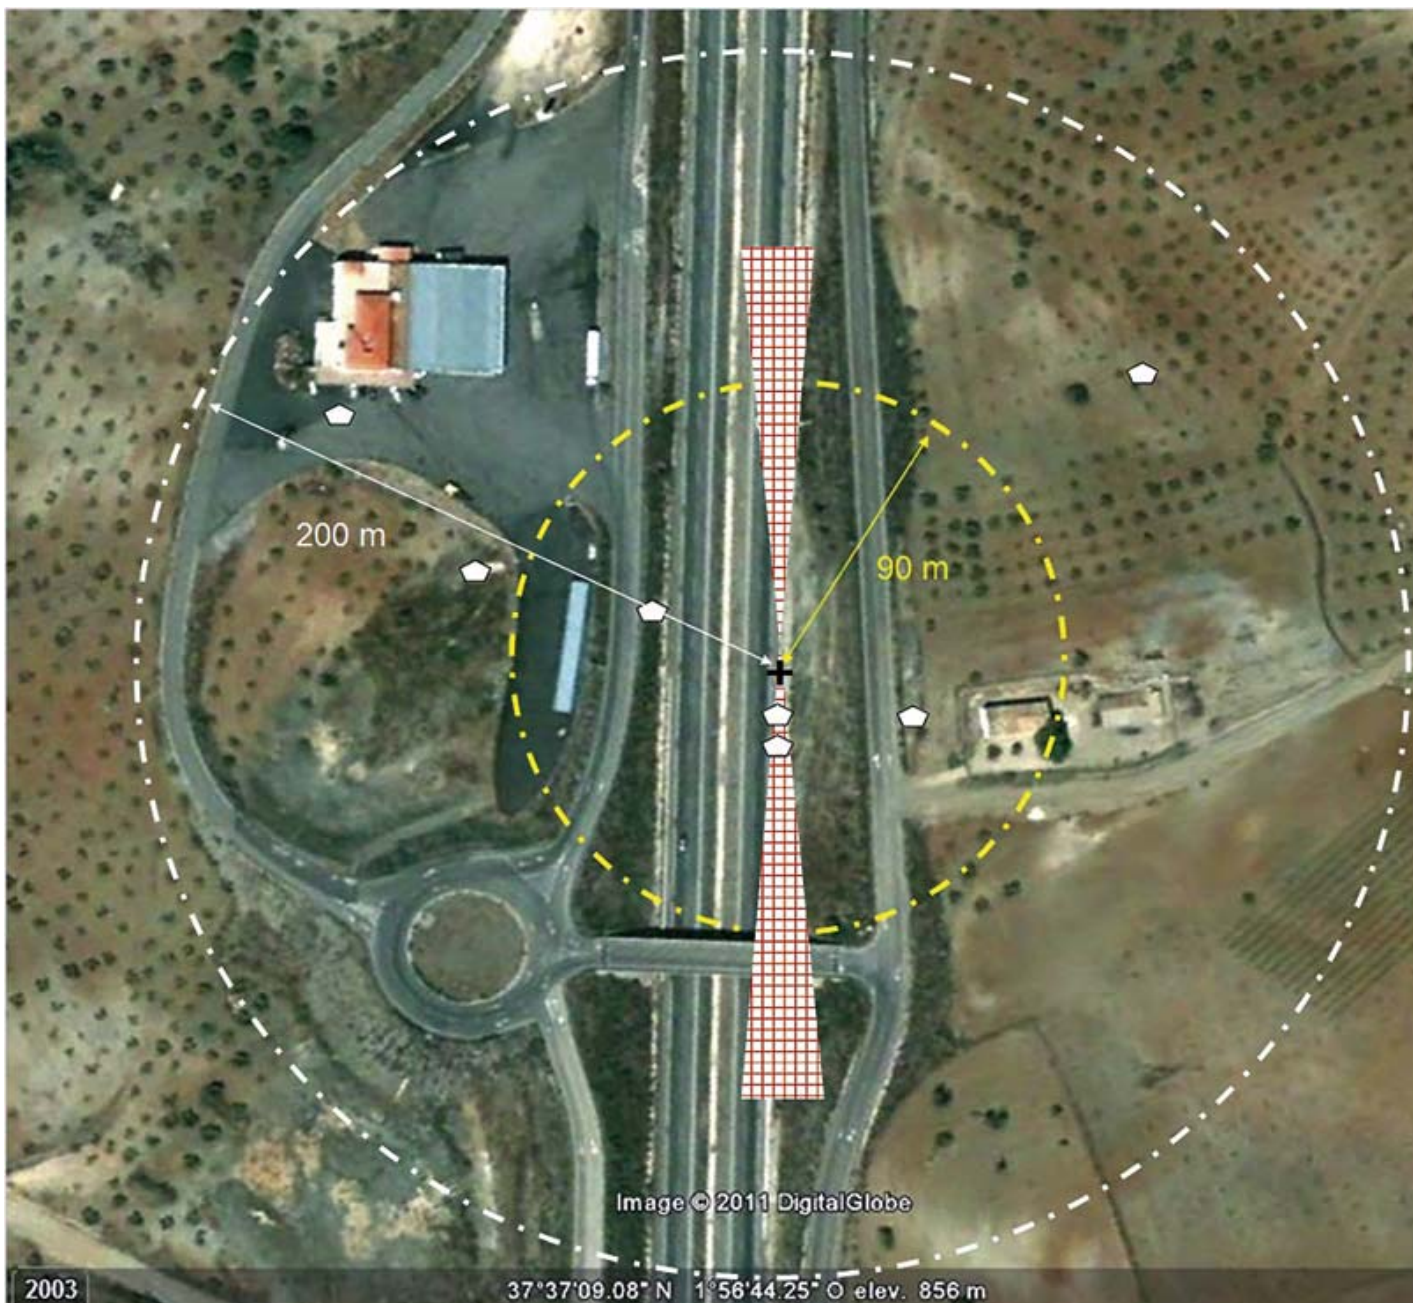
The following illustration shows, within the yellow circle, the highest intensity of the fireball's thermal radiation, while the white circle ring-fences the shrapnel distance. The pentagonal figures in white represent the seven baffle plates that were contained inside the tanker. The spatial projection of the tanker is shown in the red-and-white gridded area with the tanker itself in the middle. The petrol station appears in the upper left.

Figure 12. Radius of action of the explosion and zone in which the baffle-plate shrapnel fell: Authors. Source<sup>(10)</sup>

One baffle plate struck the front part (edge) of the corrugated sheet roof of the petrol station car park, standing about 150 metres from the tanker.

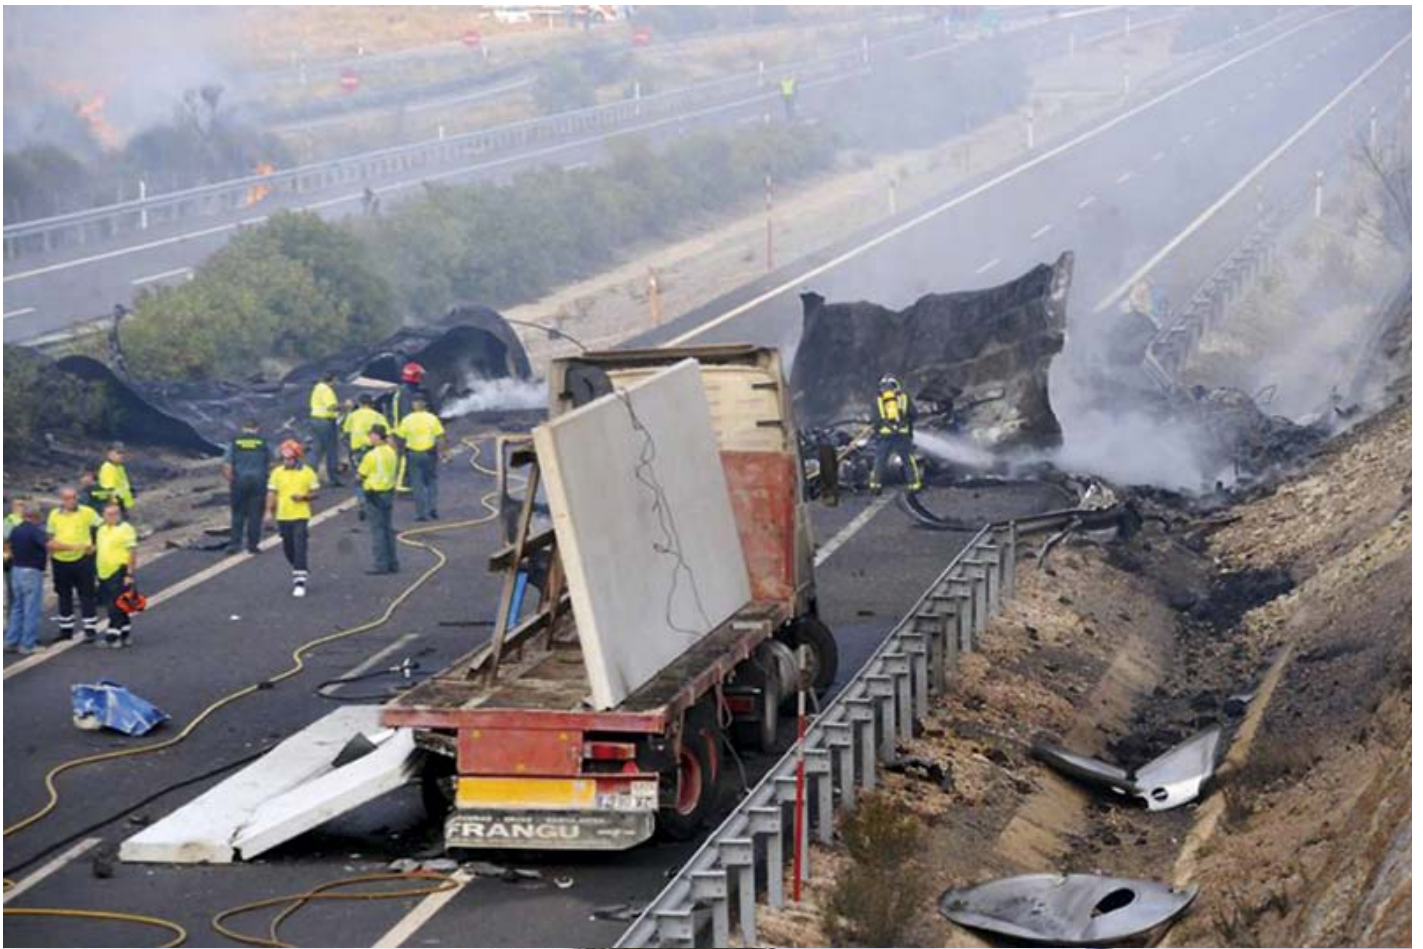
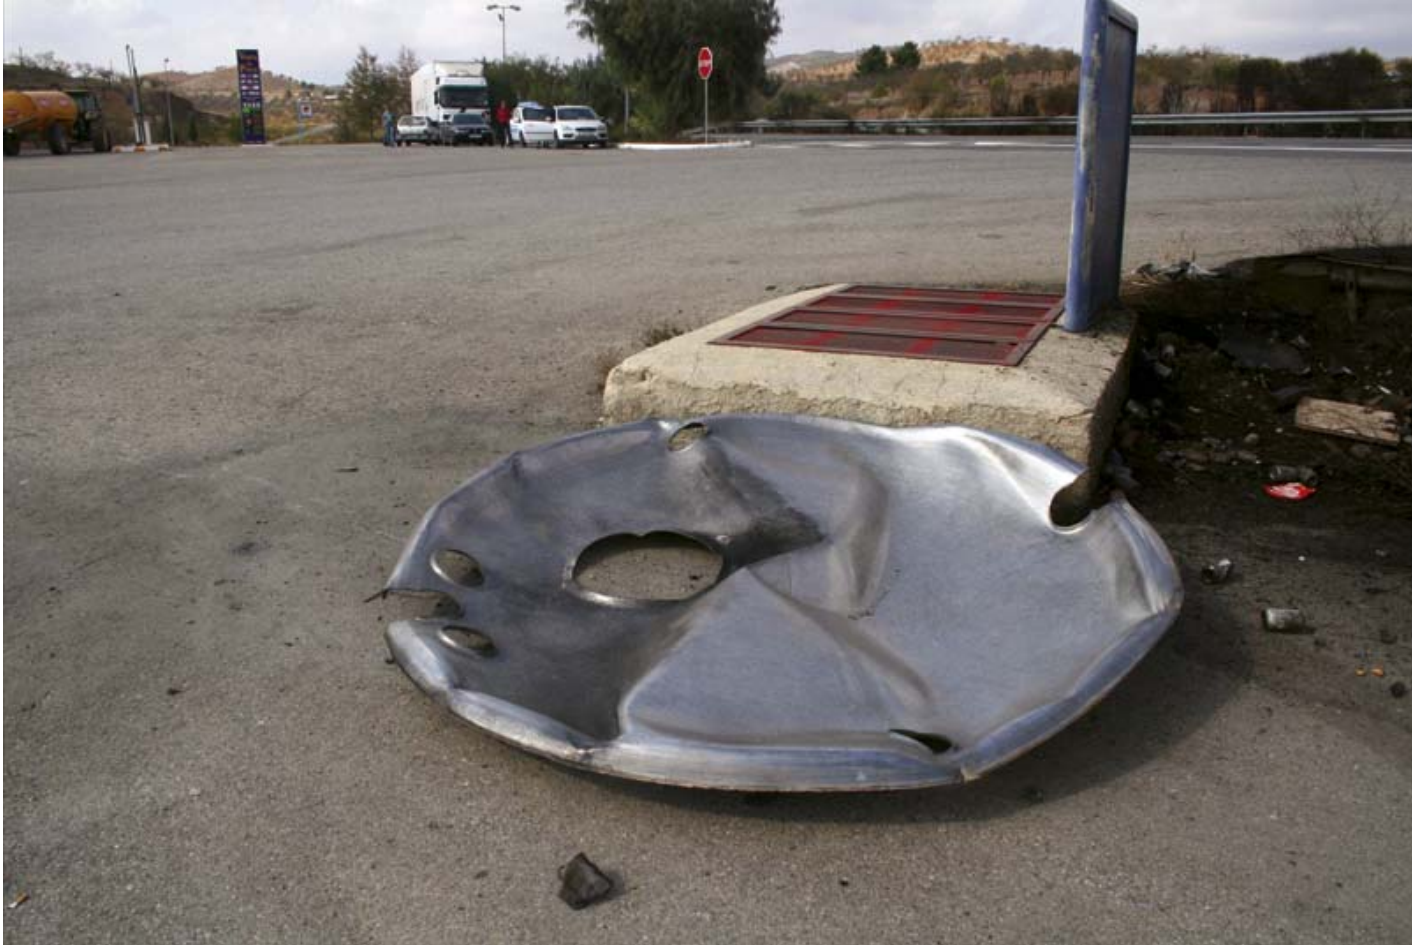
Two of the baffle plates remained beside the tanker, as shown in the following photograph. Another crossed the roadway and struck the ditch on the other side.

Figure 13. In the foreground, two of the baffle plates of the road tanker. Source: On-the-spot witness.
