The Canterbury Earthquake Sequence of 2010-2011, New Zealand: a review of seismology, damage observations and consequences

Dr. Kelvin Berryman
PhD, Manager, Natural Hazards Research National Platform, GNS¹ Science

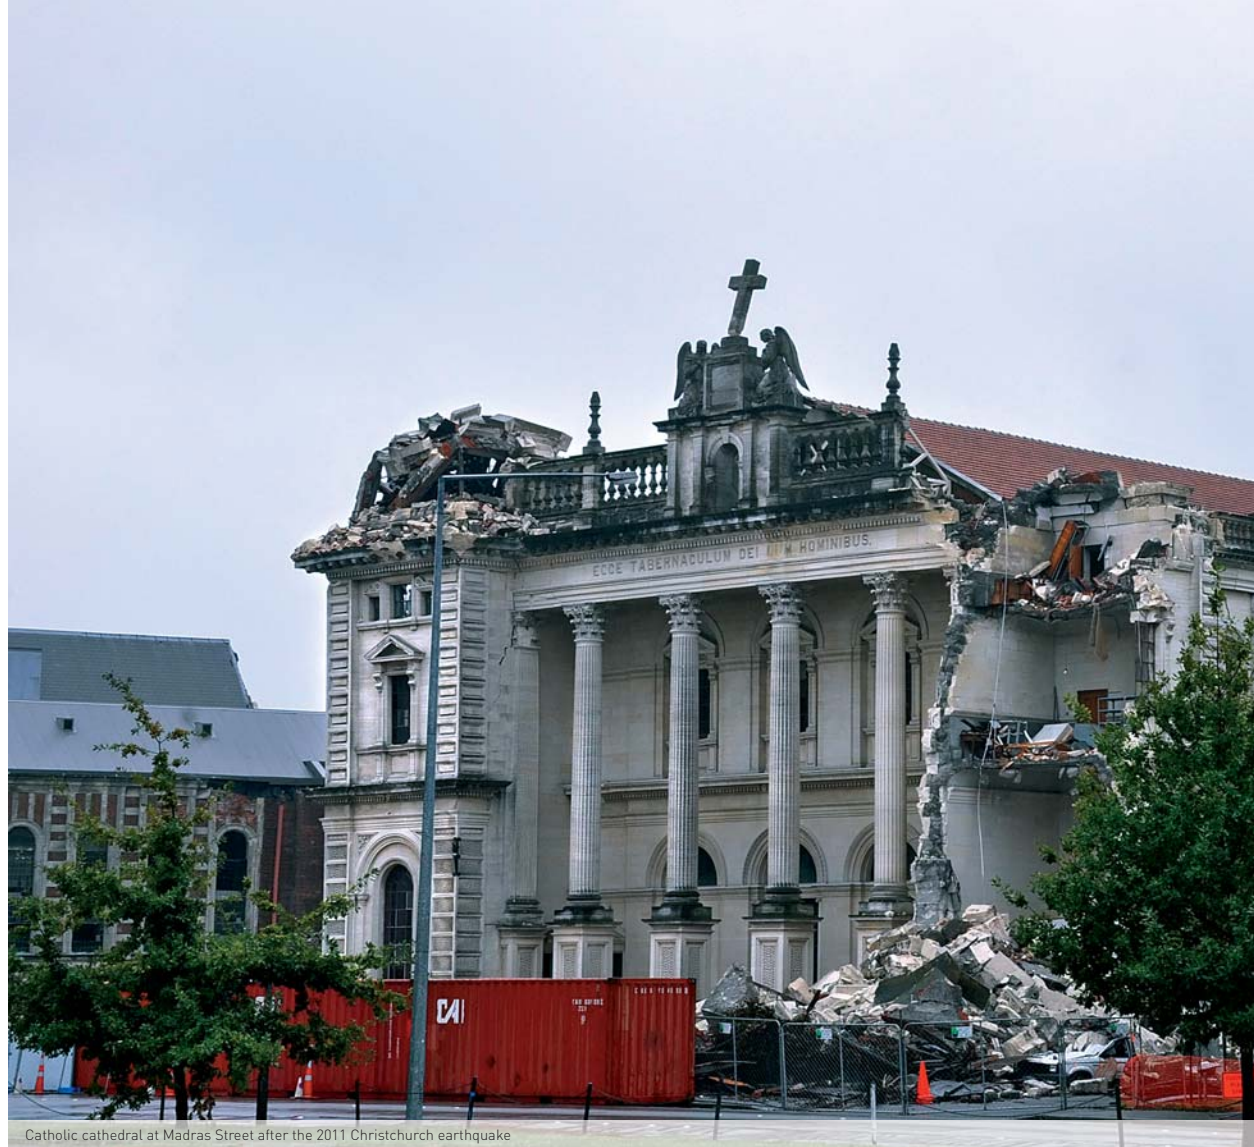
Catholic cathedral at Madras Street after the 2011 Christchurch earthquake

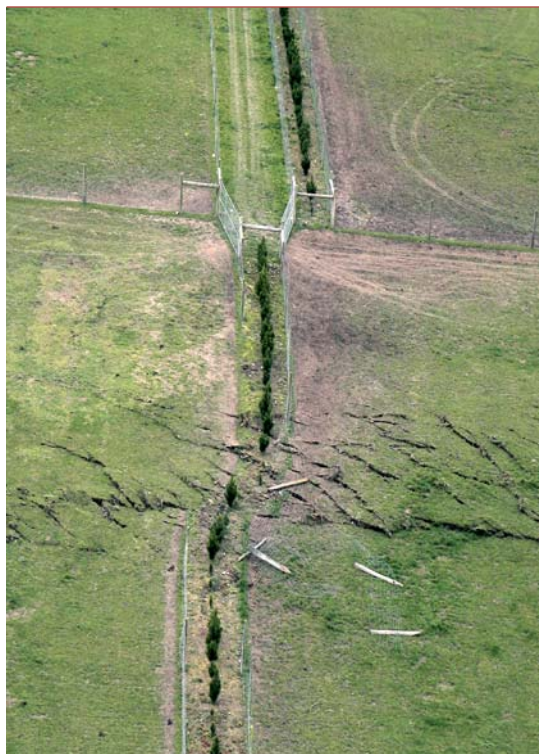
Figure 5: Example of farm fences displaced by surface rupture of the Greendale fault during the 4 September 2010 Earthquake. (Photo: Nicola Litchfield, GNS Science).

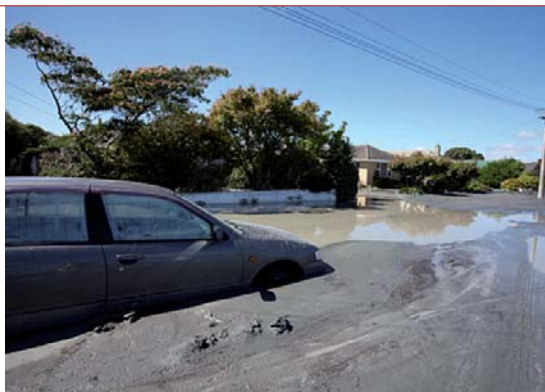
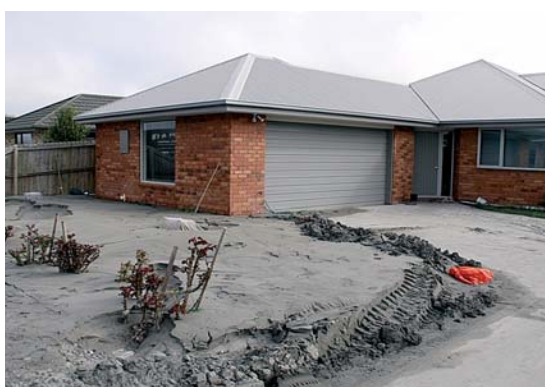
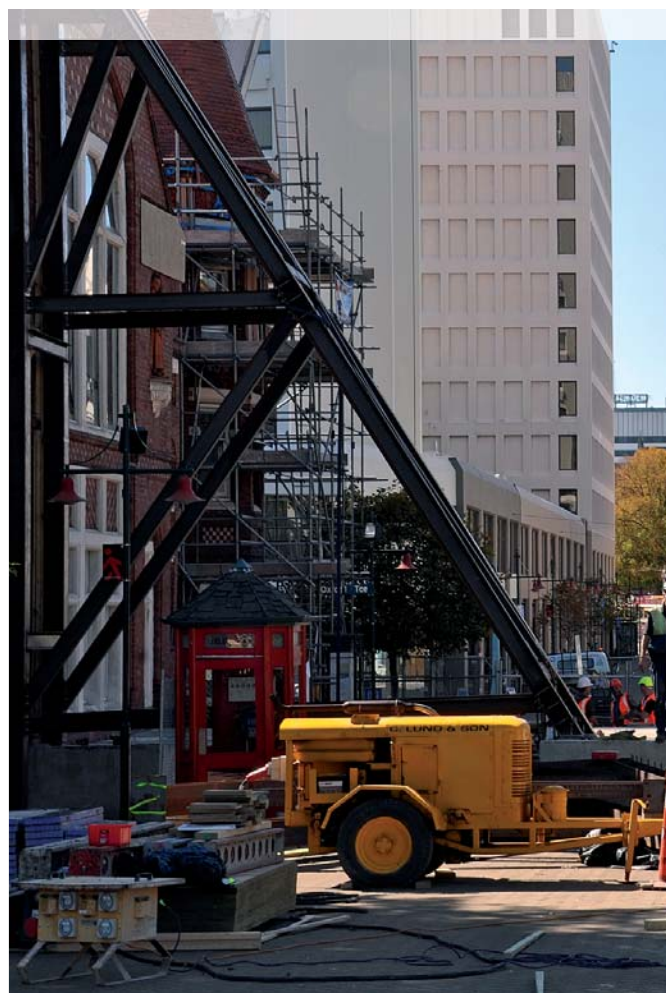
A range of liquefaction-induced phenomena were observed, including sand boils, lateral spread-induced settlement and rifting of structures of up to 3 m. Liquefaction occurred in a larger area (more than 50% of the city) than that predicted by pre-earthquake susceptibility maps, although the general indicators of susceptible areas were well known. The severity of the ground motions contributed to the extensive area of liquefaction, but also the threshold for damaging liquefaction occurrence was very low ground motions of only 0.1-0.15 g PGA in the most susceptible areas. Where lateral spreading occurred, the resulting damage to houses, underground

Figure 8: Liquefaction deposits in eastern Christchurch resulting from the 22nd February. Christchurch earthquake. Removal of this material has resulted in a significant land level lowering with respect to sea level and the water table. (Photos: Tonkin & Taylor Ltd).

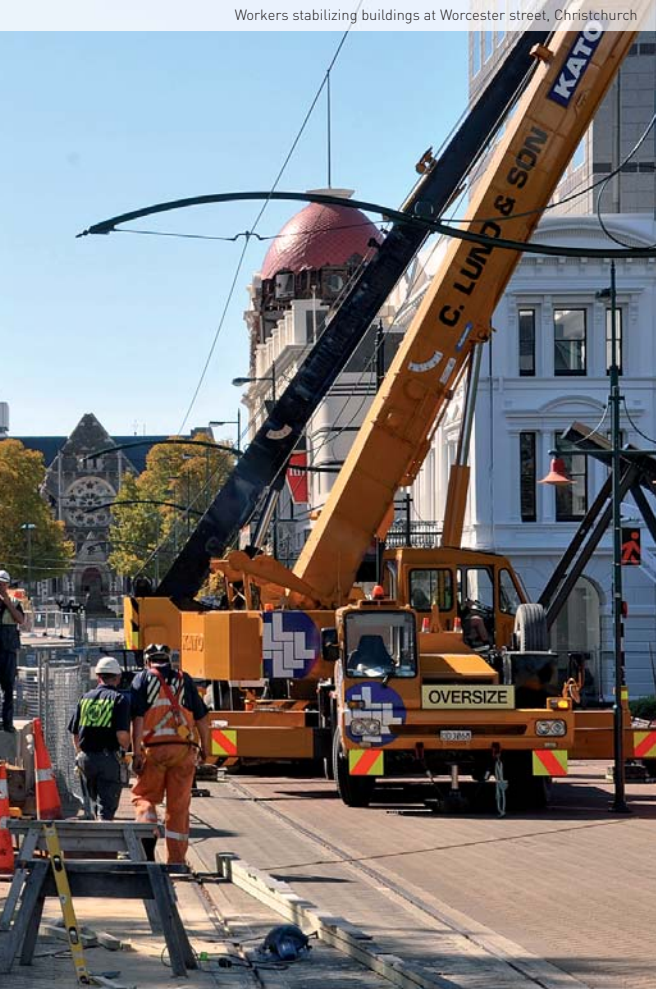
Workers stabilizing buildings at Worcester street, Christchurch

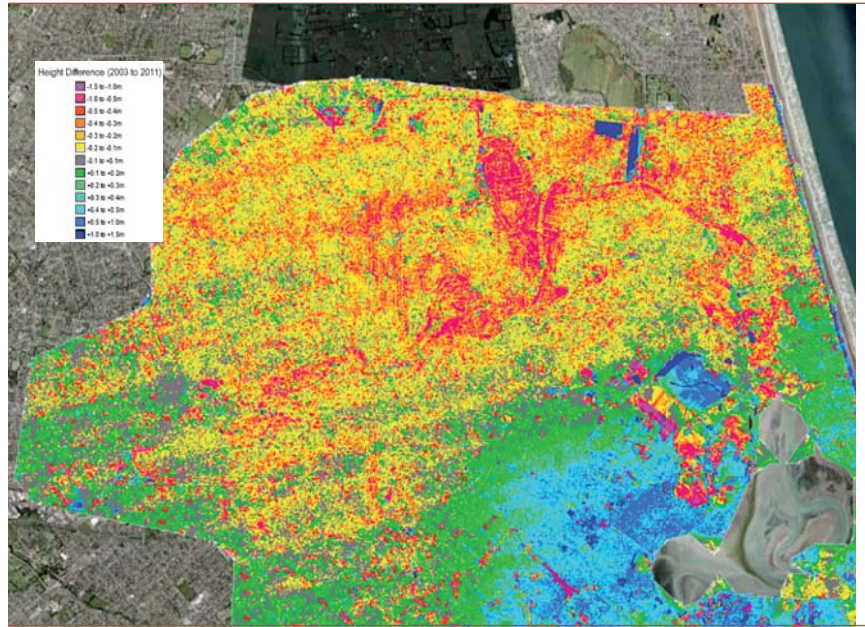
Land levels in the city area have been significantly changed as a result of the earthquake sequence. Two primary factors are responsible. There has been tectonic deformation from the blind reverse fault that ruptured in 22 February 2011 (shown as a dashed yellow line in Figure 1) resulting in uplift of up to 450 mm in the south of the city and southern hillside suburbs, and up to 150 mm of subsidence relative to sea level in coastal suburbs and along the lower reaches of the Avon River. Also lateral spreading and liquefaction (see more below) have resulted in up to 1 m of subsidence in some areas. Absolute changes in elevation with respect to sea level have increased the flooding hazard in parts of the city.

Figure 9: LIDAR image showing cumulative land elevation differences resulting largely from tectonic deformation, lateral spreading, and removal of liquefaction deposits as a consequence of the Darfield (minor impact), and Christchurch earthquakes (major impact). Note the uplift in the estuary area in the southeast quadrant and general subsidence with localised major differences in the northern half of the scene. The rectangular blue area showing uplift north of the estuary is a stockpile of liquefaction derived sediment removed from the eastern suburbs. (Image courtesy NZ Aerial Mapping Ltd).

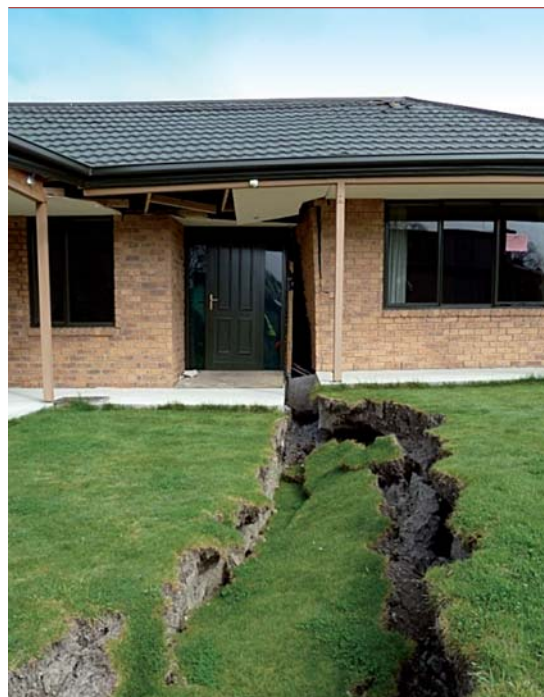
services, and to foundations of multi-story buildings in the CBD has often resulted in a total loss (Figure 10).

Figure 10: Example of a total loss of a residence in the eastern suburbs due to lateral spreading (left). (Photo: Tonkin & Taylor Ltd).

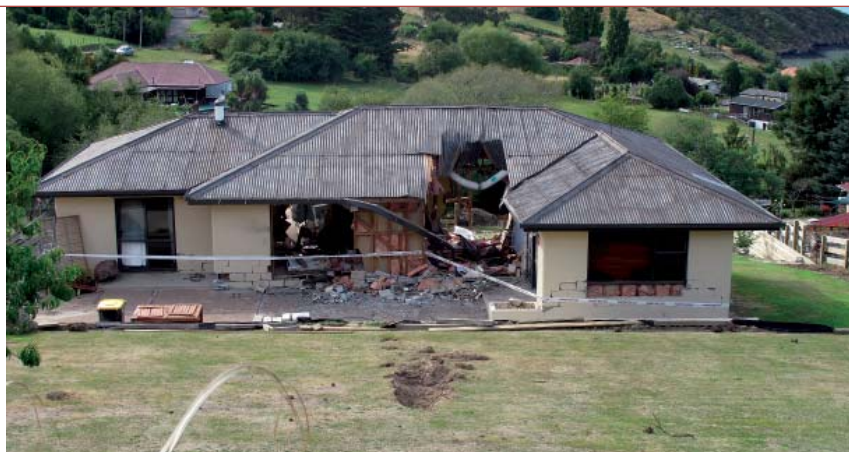
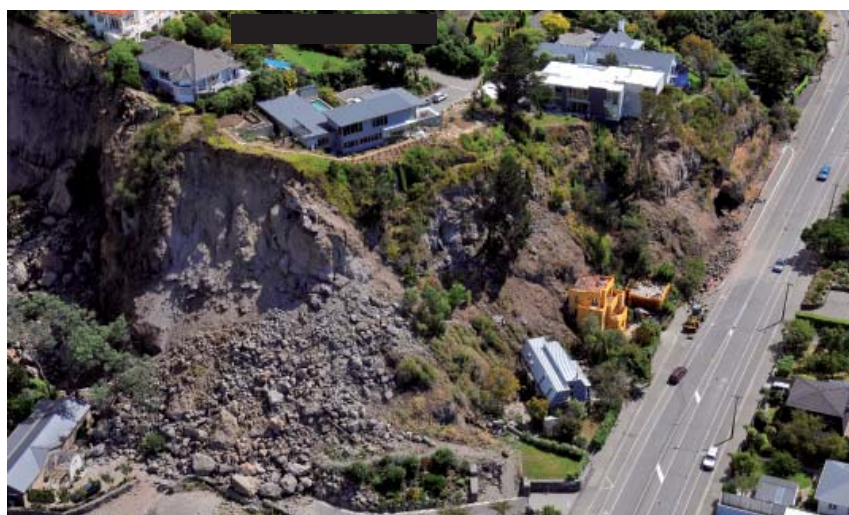
At least 100 boulders triggered by the 22nd February earthquake hit houses and there was extensive cliff collapse (Figure 11). As a consequence, about 450 residential properties in the hillside suburbs were issued with “red placards”, meaning they were assessed as too dangerous to occupy. Further boulders crashed down the slopes and hit houses, and further cliff collapse occurred during the 13th June 2011. Currently a risk assessment is being undertaken to establish tolerable or intolerable life risk to the occupiers of the “red placard” houses measured against the probabilistic earthquake shaking model. Quantitative assessment will determine

Figure 11: Example of boulder impact on house in the hillside suburbs (note the bounce mark in the foreground) (up), and cliff collapse threatening houses and occupants at both the top and base of the cliff (down).

whether retreat is necessary, whether properties can be re-occupied after cost-effective slope remediation, or establish that it is already safe to re-occupy the properties.

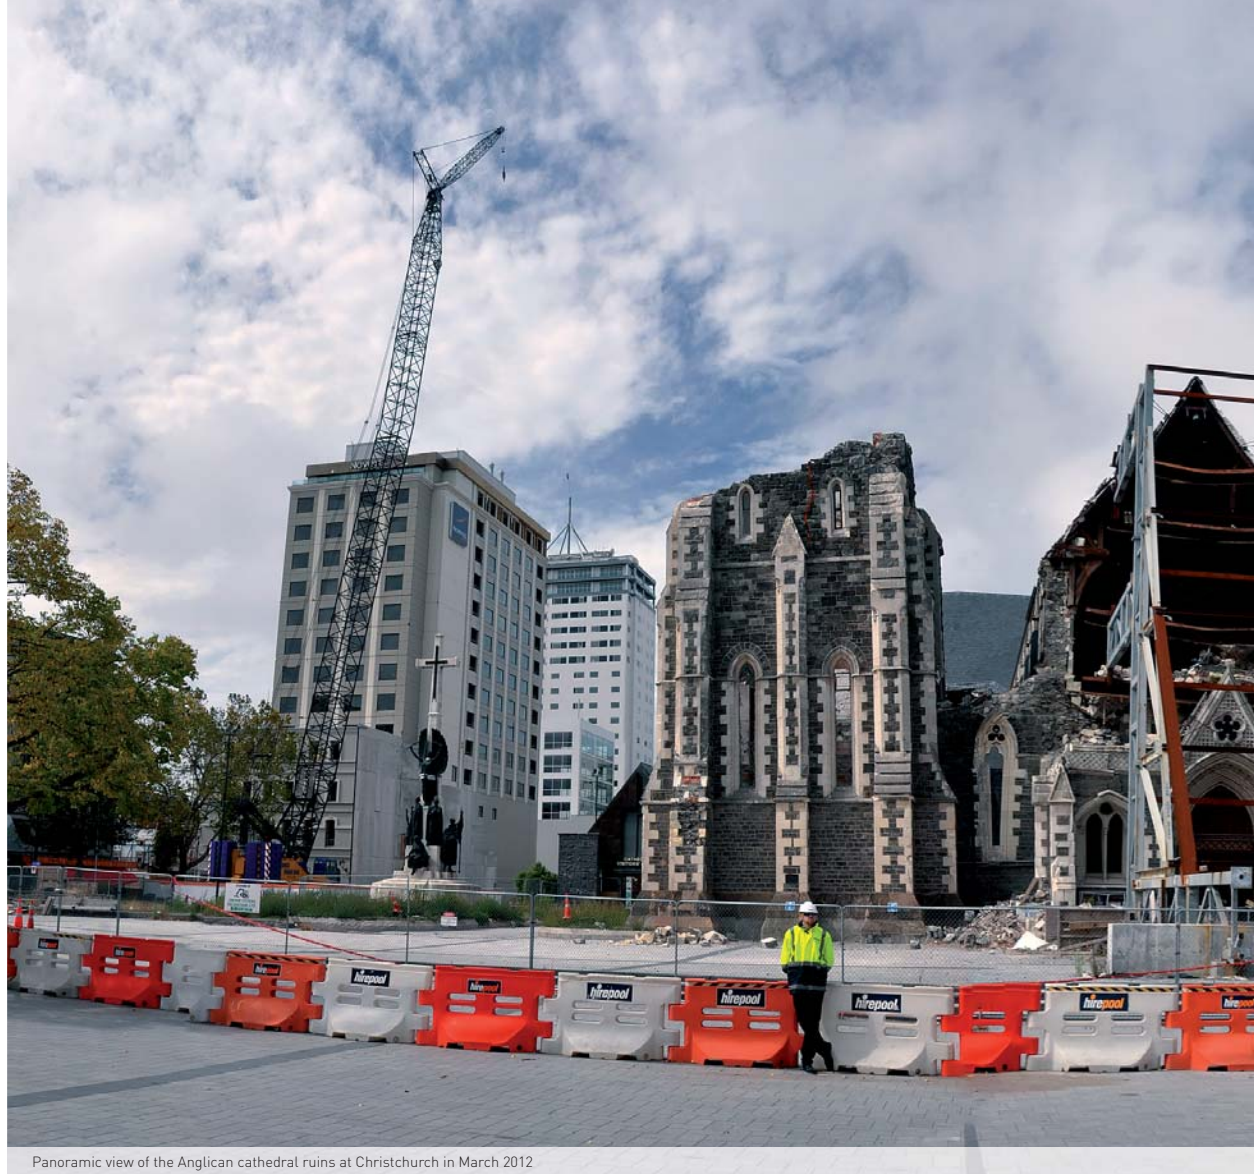
Panoramic view of the Anglican cathedral ruins at Christchurch in March 2012
