## Archaeoseismology as an emerging science

Natural risks

*Archaeoseismology involves the study of past earthquakes by analysing archaeological sites, furnishing previously unknown information on seismic events that might not even have been recorded in history. This data can help to ascertain the seismic danger of relatively stable areas with long return periods of highly destructive earthquakes, such as the Iberian Peninsula.*

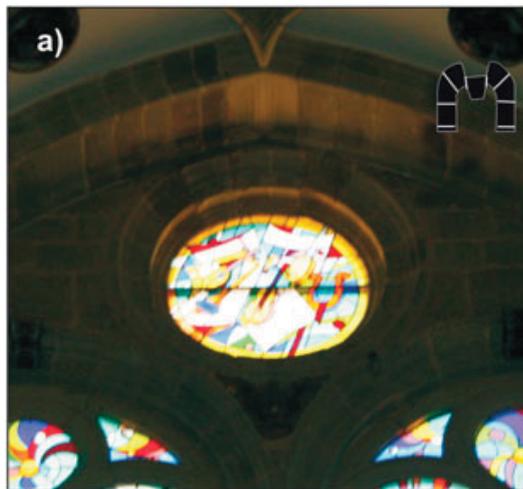
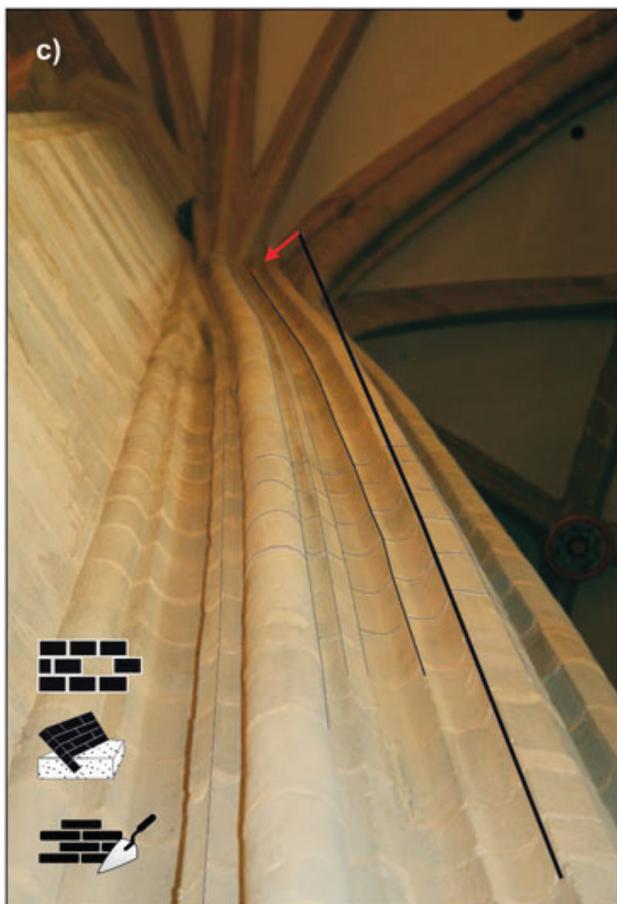
Astorga Cathedral,  
León, Spain

Figure 7. Co-seismic effects inside Astorga Cathedral (León). a) Displacement of the keystones in a small rose window in one of the side chapels. b) Decimetric displacement of the masonry blocks in one of the columns separating the crossing from the nave. c) Cumulative displacement of the masonry blocks making up one of the columns, visible displacement even with signs of thoroughgoing repairs. d) Masonry block displacement in the connection of the nave with one of the south facing windows.

Another of the visible effects is the dropping of the upper keystones of a small rose window in the lunette of the northern chapel of the cathedral crossing (Fig. 7a).

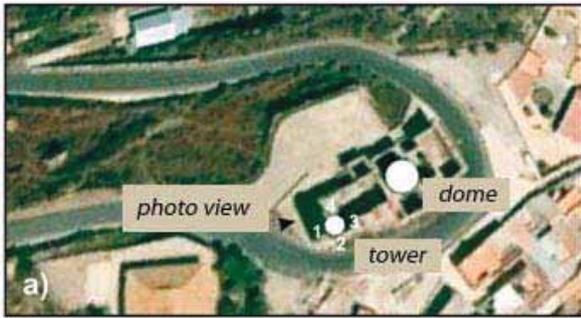
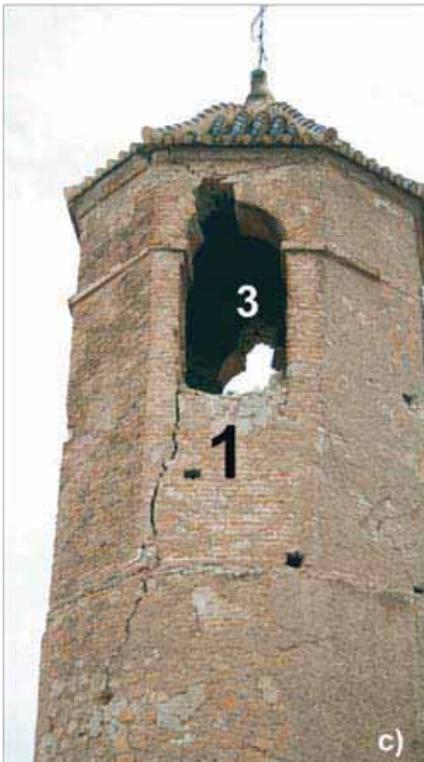
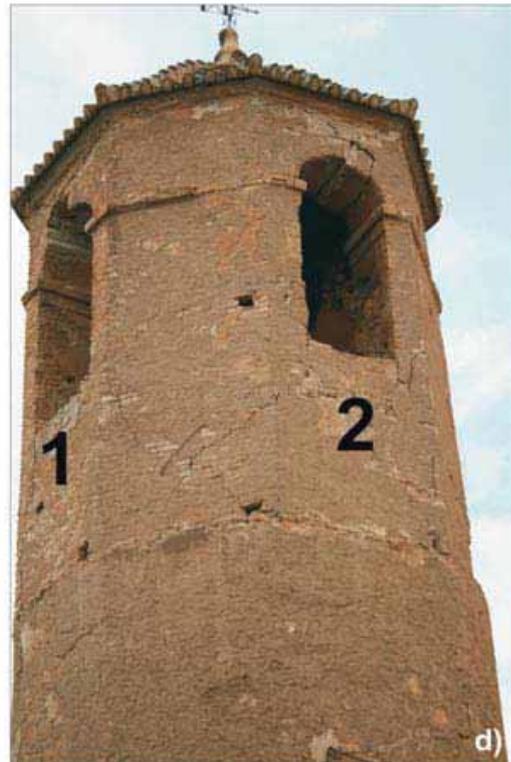
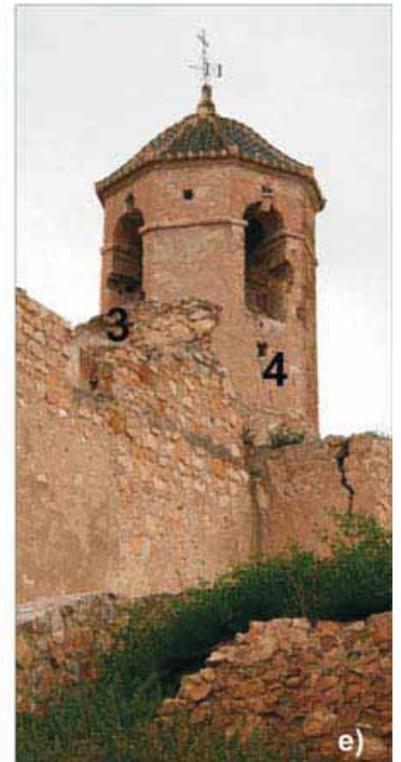
Figure 14. Damage to the tower of the C15th church Iglesia de San Juan in Lorca (Murcia).

The C15th Iglesia de San Juan (siglo XV) shows diverse damage to the tower windows, varying in degree according to their orientation (Fig. 14). Due to the collapse of the arch (see Fig. 5), the windows running NW-SE 170° show greater damage than those running at right angles to them (Fig. 15); this tells us the main orientation of the damage-causing deformation tensor (orientation of  $e_y$ ).

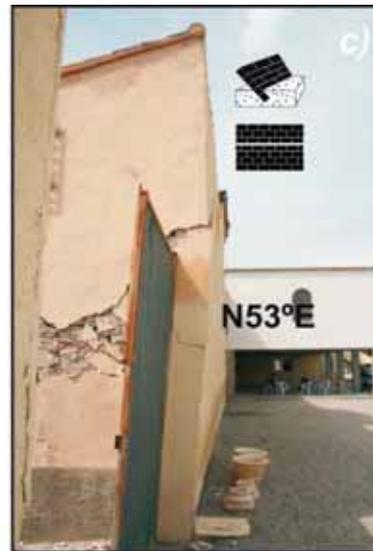
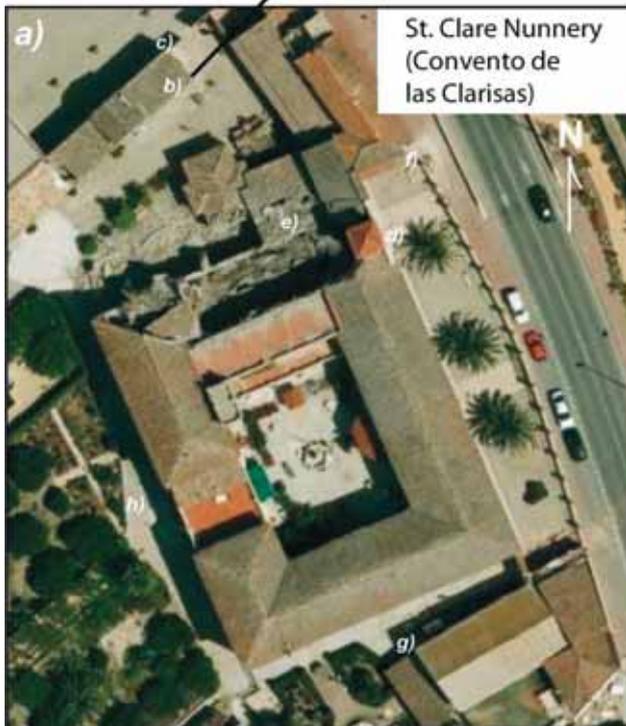
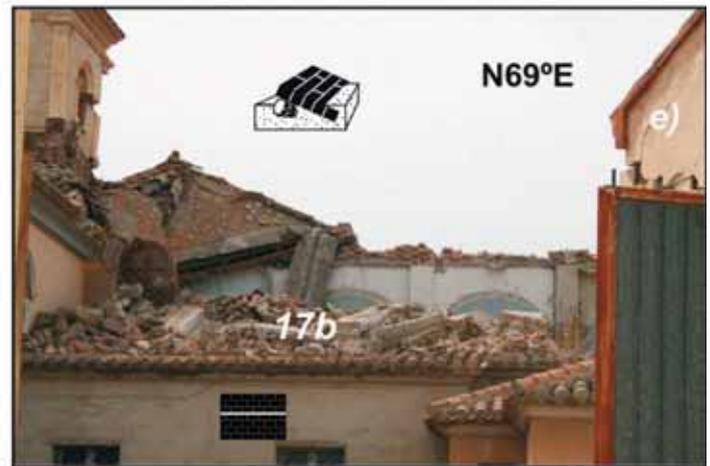
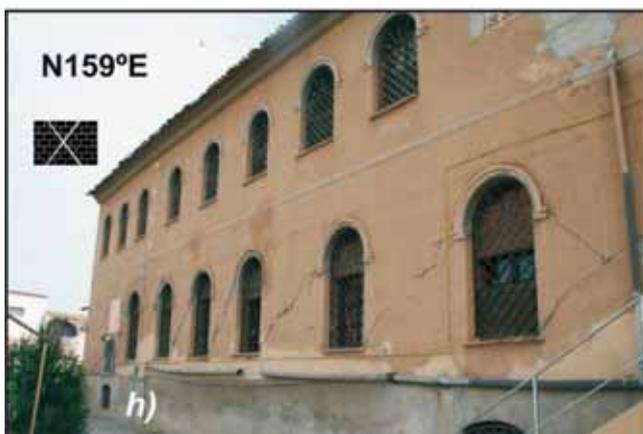
Figure 16. Damage to the Monasterio de Santa Ana y la Magdalena de las Clarisas, in Lorca (Murcia). a) Bird's eye view of the nunnery buildings and location of the main damage. (b) and (h) Conjugated fractures in walls of various buildings of the nunnery; (c) Fracture and displacement of the NW wall of a building annexed to the church; fallen and oriented walls in different structures: (d) in a small belltower; (e) in the NW wall of the nunnery church; (g) in a building annexed to the church, and in one of the corners of the main front (g).

In the case of the St. Clare Nunnery, fairly severely damaged by the earthquake (Fig. 16), the analysis shows a uniform orientation of  $e_y$  in the direction NW-SE (Fig. 17), chiming in with the results obtained in over 80 analysis points throughout the town.
