# The eye of the storm

Hurricane Odile has become —along with Olivia (1967)— the most devastating ever to hit the Mexican state of Baja California Sur. Its effects also extended to other areas of the Mexican Atlantic Coast and the southwest of the United States. Odile hit land on 14 September 2014 at category 3 (Saffir-Simpson scale). There were six dead and the material damage is estimated at about 2.5 billion dollars, approximately half of which (1.2 billion) was insured. Hotel infrastructure, the area's main source of economic activity, was seriously affected. The analysis of the damage to these establishments allows us to draw conclusions on the importance of preventing this phenomenon in the hotel sector.

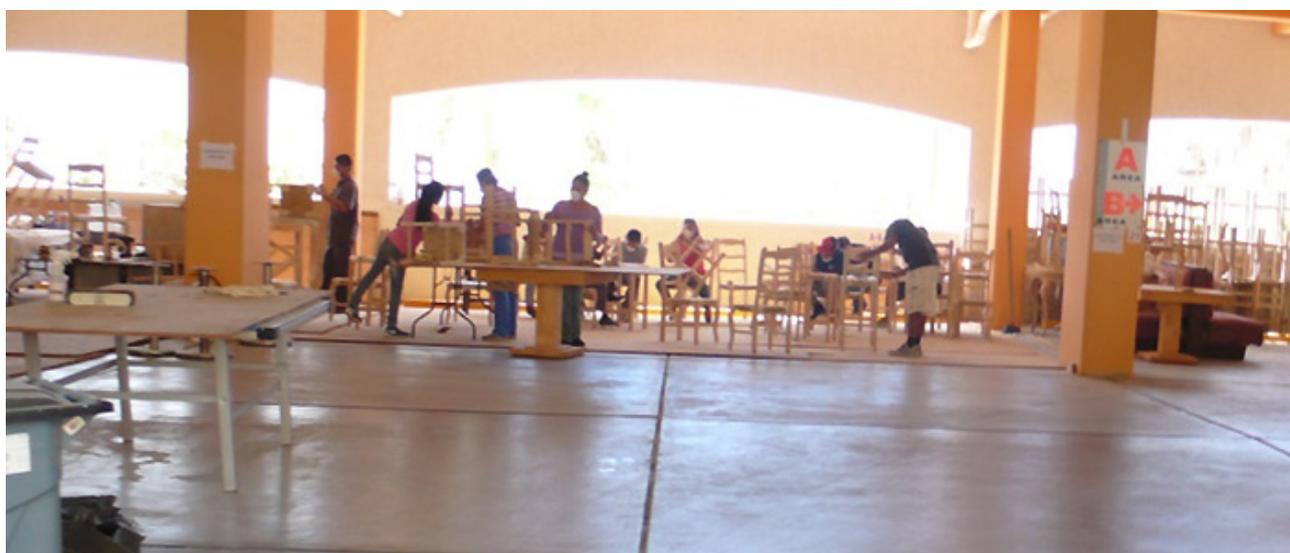
*Personal de un hotel realizando labores de limpieza de mobiliario.*

One important aspect to consider within the contingency plan is the involvement of the hotel's own staff in restoring and cleaning the facilities. In this regard, any possible professional incompatibility that may be established by the legislation of each country for undertaking these tasks must be taken into account.
