## Analysis of the explosion of a liquefied-natural-gas road-tanker

*This article describes a liquefied-natural-gas tanker accident in the Spanish province of Murcia, with subsequent ignition and explosion of the cargo. The effects were notable in terms of thermal radiation, overpressure blast wave and flying shrapnel. This was the second known accident of this type in the world. In 2002 a similar accident occurred in Tivissa (Tarragona). This article looks at the possible causes, draws conclusions and puts forward recommendations for avoiding accidents of this type in the future.*

Authors: J.M. BONILLA MARTÍNEZ. Chemical Engineer, Industrial Engineer, Fire-fighting Officer. ([wjuanma@yahoo.com](mailto:wjuanma@yahoo.com)).

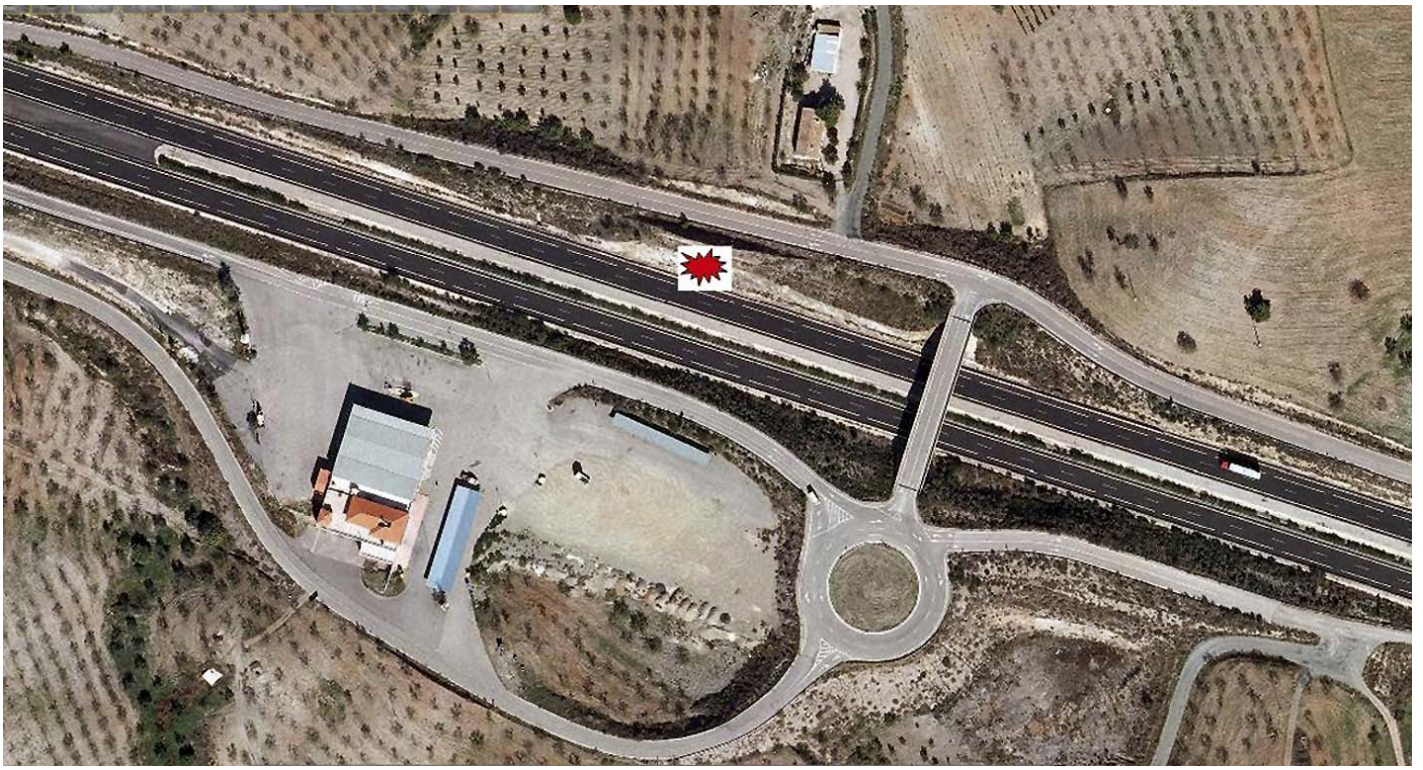
The accident happened at kilometre point 3.5 of the A-91 motorway running from Puerto Lumbreras to Granada. The height above sea level of the accident site is 856 metres. About 150 metres from the accident spot, on the other side of the road (the southwards carriageway), stands a petrol station with cafeteria-restaurant, shop and HGV drivers' resting point. Ninety metres away, next to a service road running parallel to the accident road (northwards), stands an inhabited country lodge. Alongside the explosion site, on the hard shoulder of the motorway runs an earth and rock embankment about 10 metres high on average.

Figure 1. Bird's eye view of the accident area. Source<sup>(1)</sup>
